Sanitary Survey Report and Sampling Plan for Dungarvan

AQUAFAC International Services Ltd

The Sea Fisheries Protection Authority
August 2021

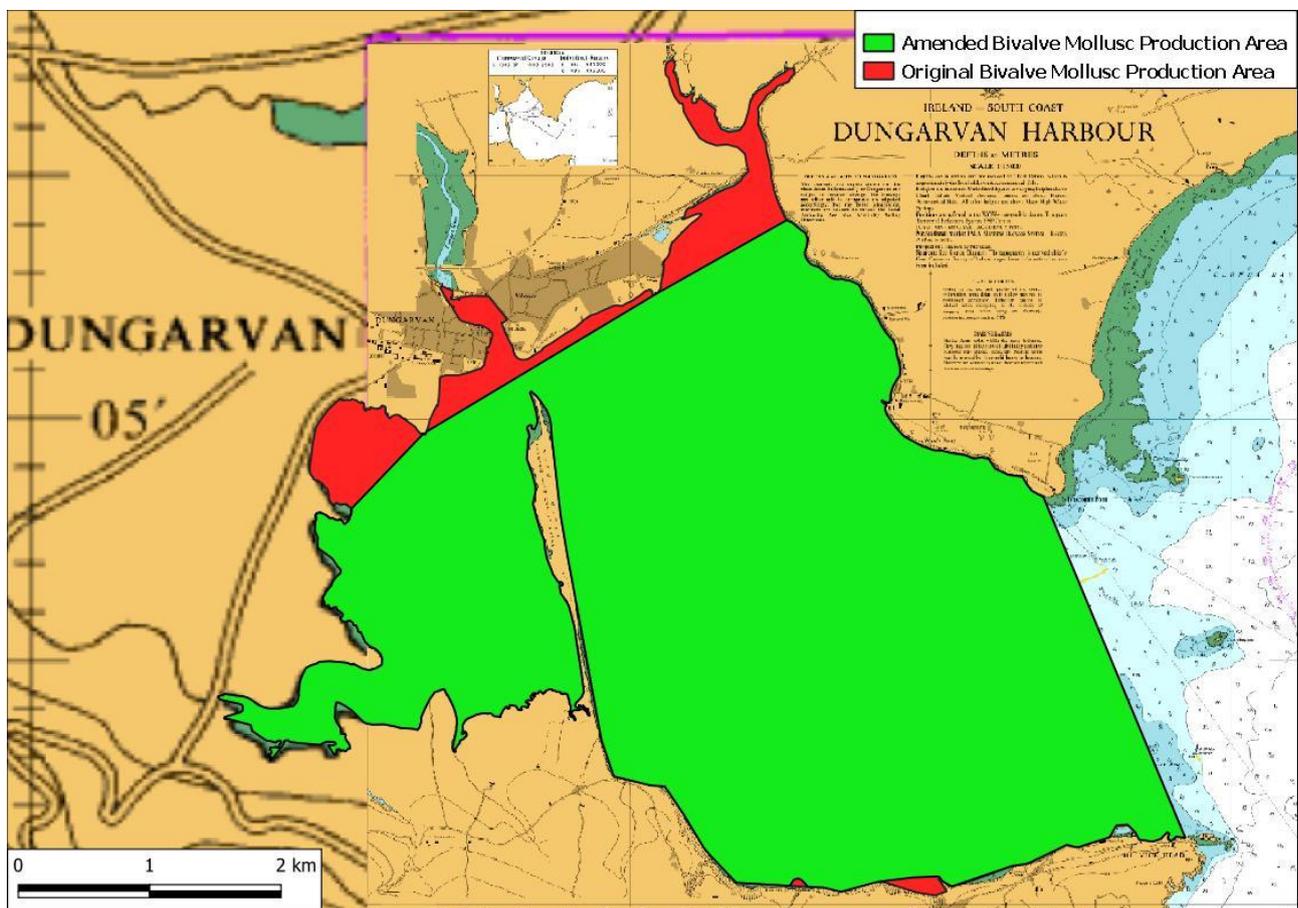
Figure 4.1: Amendments to Dungarvan Bivalve Mollusc Production Area.

Further minor amendments have been made to exclude the areas which two pumping station overflows discharge impact at Baile Na nGall and An Mota. The amendments can be seen in Figure 4.1 below.

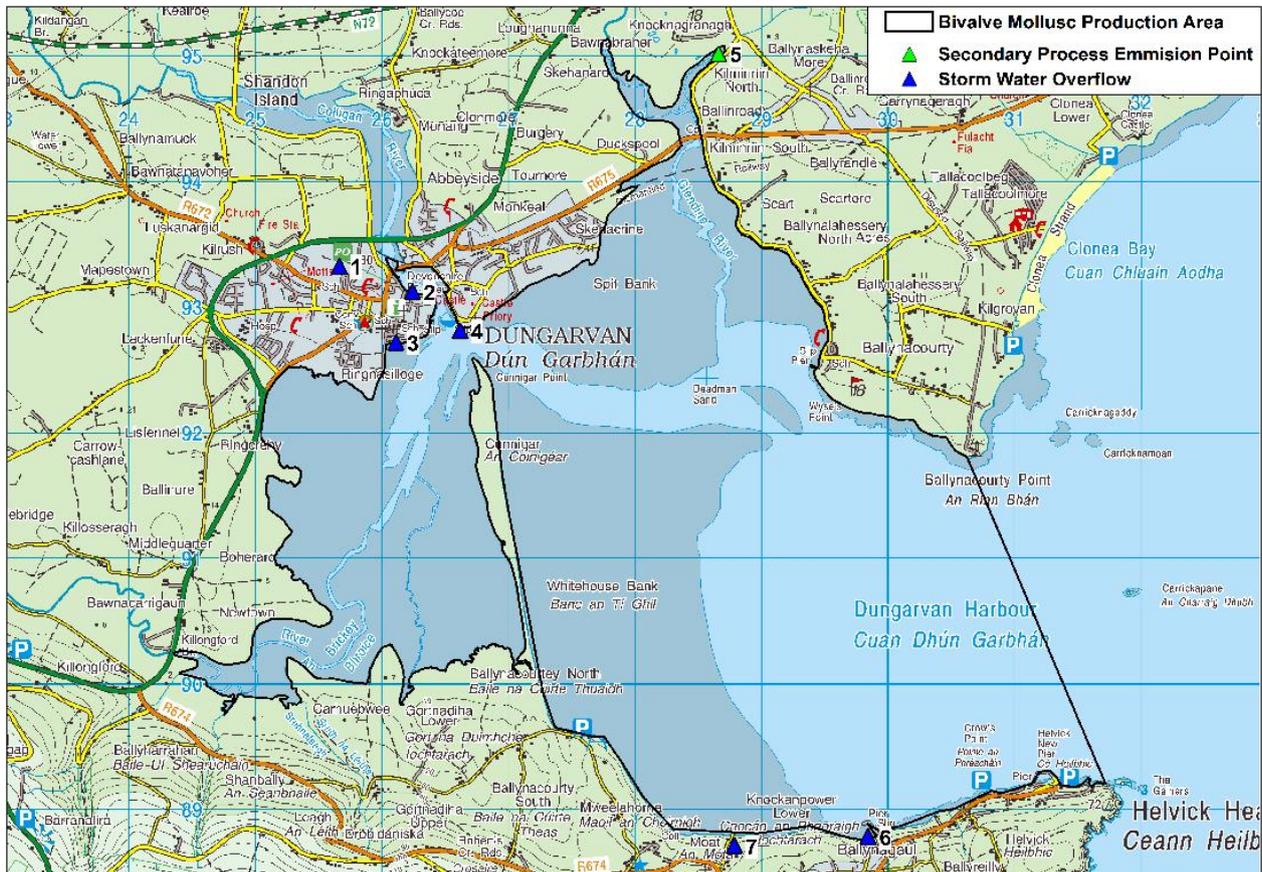
Figure 6.6: Rainfall Dependent Discharges associated with the Sewage Treatment Works within the Dungarvan Harbour Catchment Area (Source: The EPA, 2019b). Irish Water are currently undertaking ‘Drainage Area Plan’ studies and this may result in the reclassification of certain overflows as either storm water overflows or emergency overflows (2021)

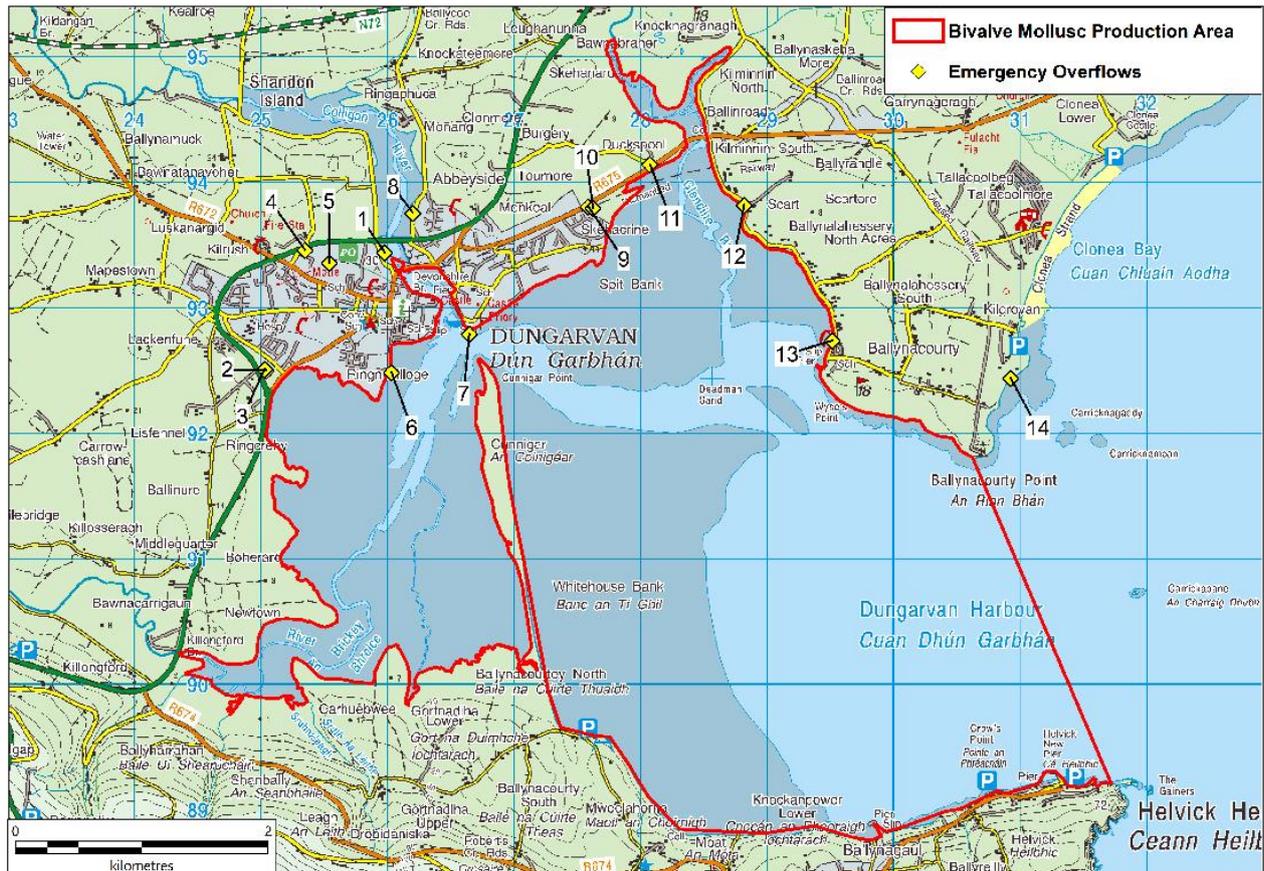
In addition to the storm water overflows there are a number of emergency overflows belonging to Dungarvan WWTP. In total there are fourteen emergency overflows which can be seen in Figure 6.7 and the details can be seen in Table 6.8. These discharges are largely associated with relief points from pumping stations in the event of mechanical failure or power outage (Nicholas O’Dwyer, 2018).

Figure 6.7: Emergency overflows within Dungarvan Harbour (Nicholas O'Dwyer, 2018). Irish Water are currently undertaking 'Drainage Area Plan' studies and this may result in the reclassification of certain overflows as either storm water overflows or emergency overflows (2021).

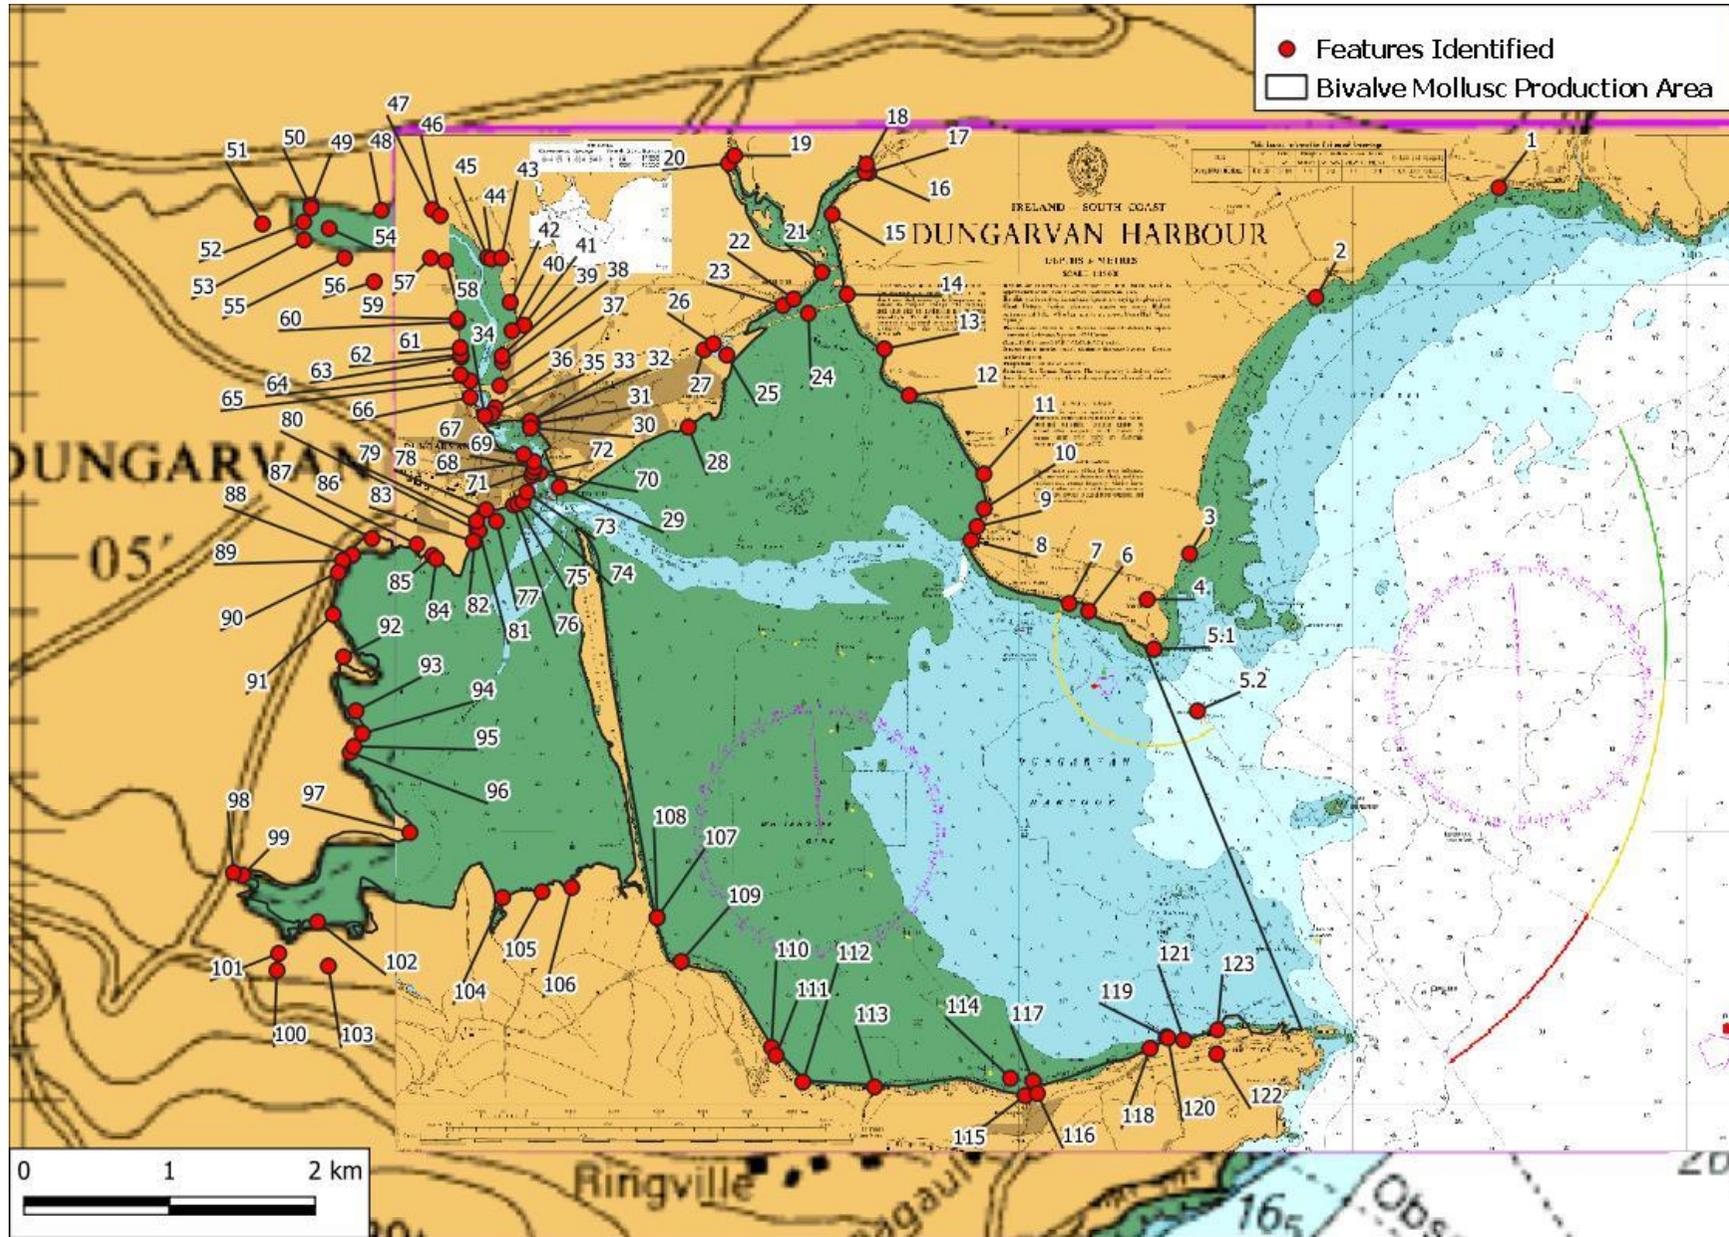
Figure 6.24: All features (numbering cross-reference to Table 6.16) identified during the shoreline survey.

Figure 6.24 and Figure 6.25 show the locations of all features observed during the shoreline survey. In total 123 features were identified, of which 14 rivers/streams were identified, 16 drains, 64 pipes, 2 discharges, 2 culverts, 3 piers, 1 marina, 3 WWTP, 4 discharges from WWTP and a WWTP pumping station. Figure 6.26 to Figure 6.39 show aerial imagery of the location of the features and Appendix 6 shows images of most of these features. Table 6.16 details all features identified and the numbering used is cross-referenced to Figure 6.26 to Figure 6.39 and Appendix 6.
