Sanitary Survey Report and Sampling Plan for Sligo Harbour

AQUAFACT International Services Ltd

The Sea Fisheries Protection Authority
November 2020

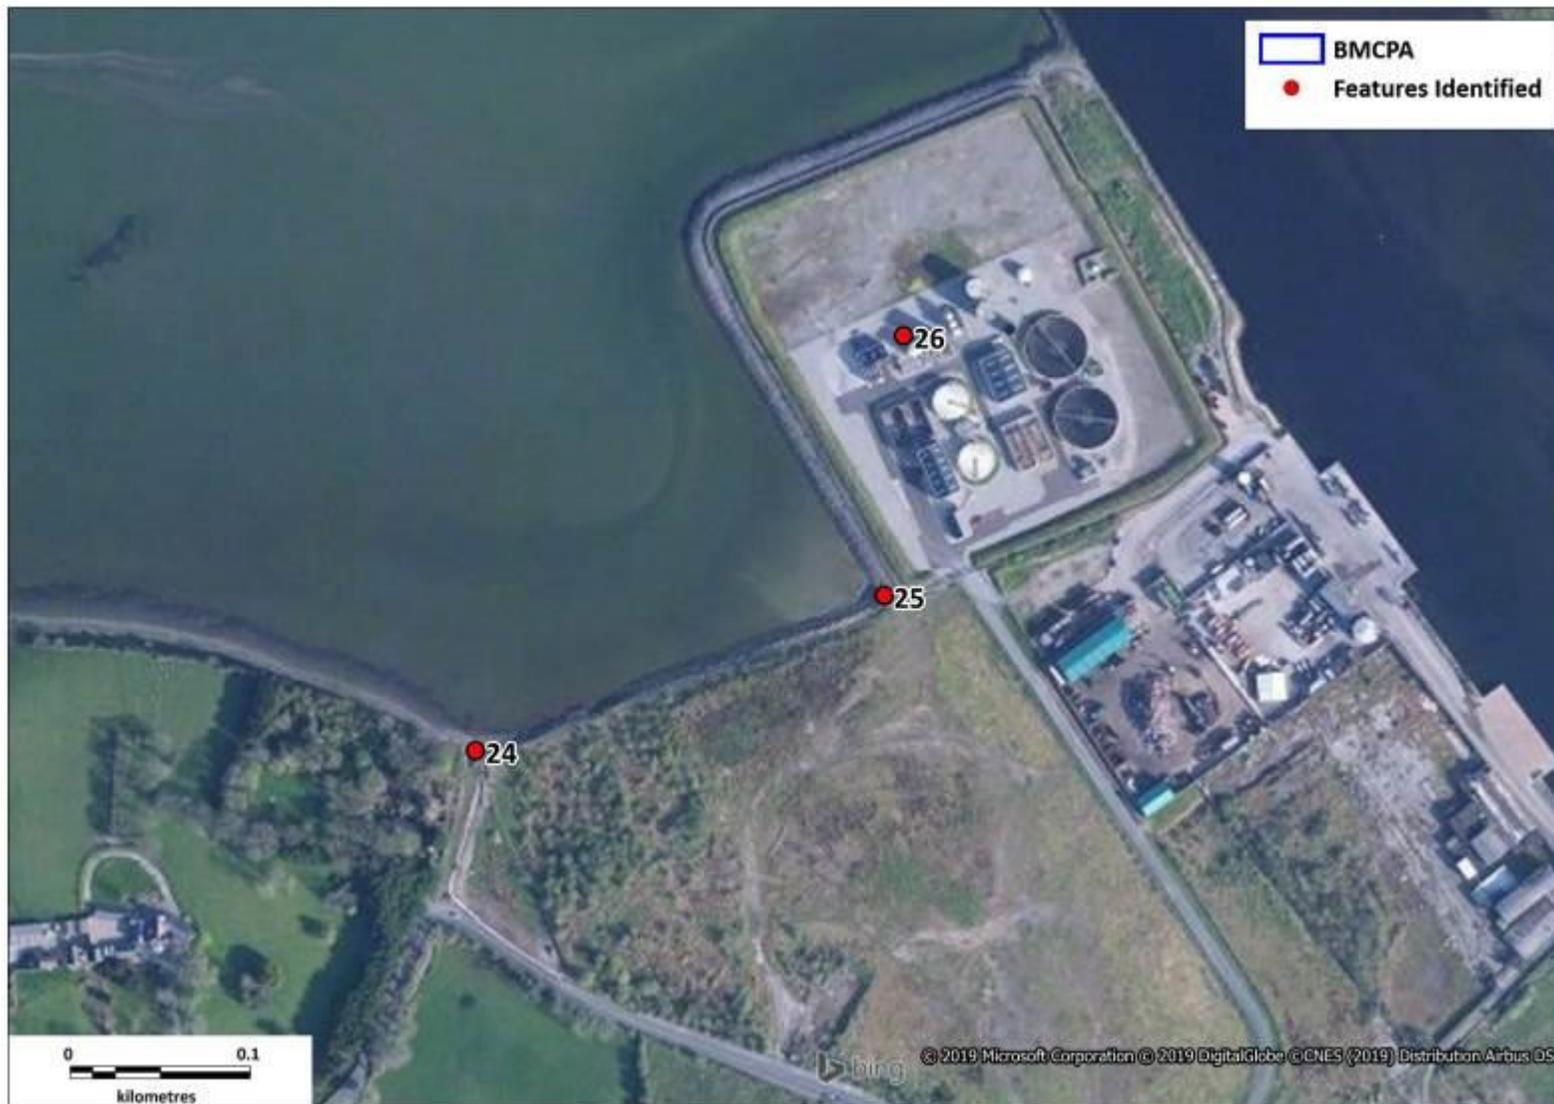
Figure 3.29: Features 24-26 (numbering cross-reference to Table 3.13) identified during the shoreline survey.

Map Code	Observation	Comments	Longitude	Latitude	Easting	Northing
24	Drain/upwelling	Enrichment, iron staining. Broken pipework	-8.50045	54.2823	167454.1	337169.1
25	Drain hole pipe	Likely to be storm overflow from WWTP	-8.49697	54.28307	167681.6	337252.9
26	WWTP Sligo	Treatment Plant	-8.4968	54.28435	167693.5	337395.6
27	Large pipe	Opposite homeland	-8.48657	54.27925	168356	336823.3
28	Upwellings	Upwellings, pipes unseen. Possibly wwtp related.	-8.48647	54.27907	168362.4	336802.9
29	Large pipe	Adjacent waste water treatment plant, covered by high tide	-8.48538	54.27888	168432.9	336781.9
30	Two pipes	Two pipes running in at same spot	-8.48533	54.27847	168435.8	336735.6
31	Marina	Marina in Sligo town, 15 odd boats assembled here	-8.4802	54.27595	168768.3	336453.1
32	Drain - Gated around exit point	Good flow, adjacent marina. Not possible to access.	-8.47925	54.27548	168829.8	336400.7
33	Drain - likely storm water	No flow, no enrichment evident	-8.4778	54.27438	168923.5	336277.6

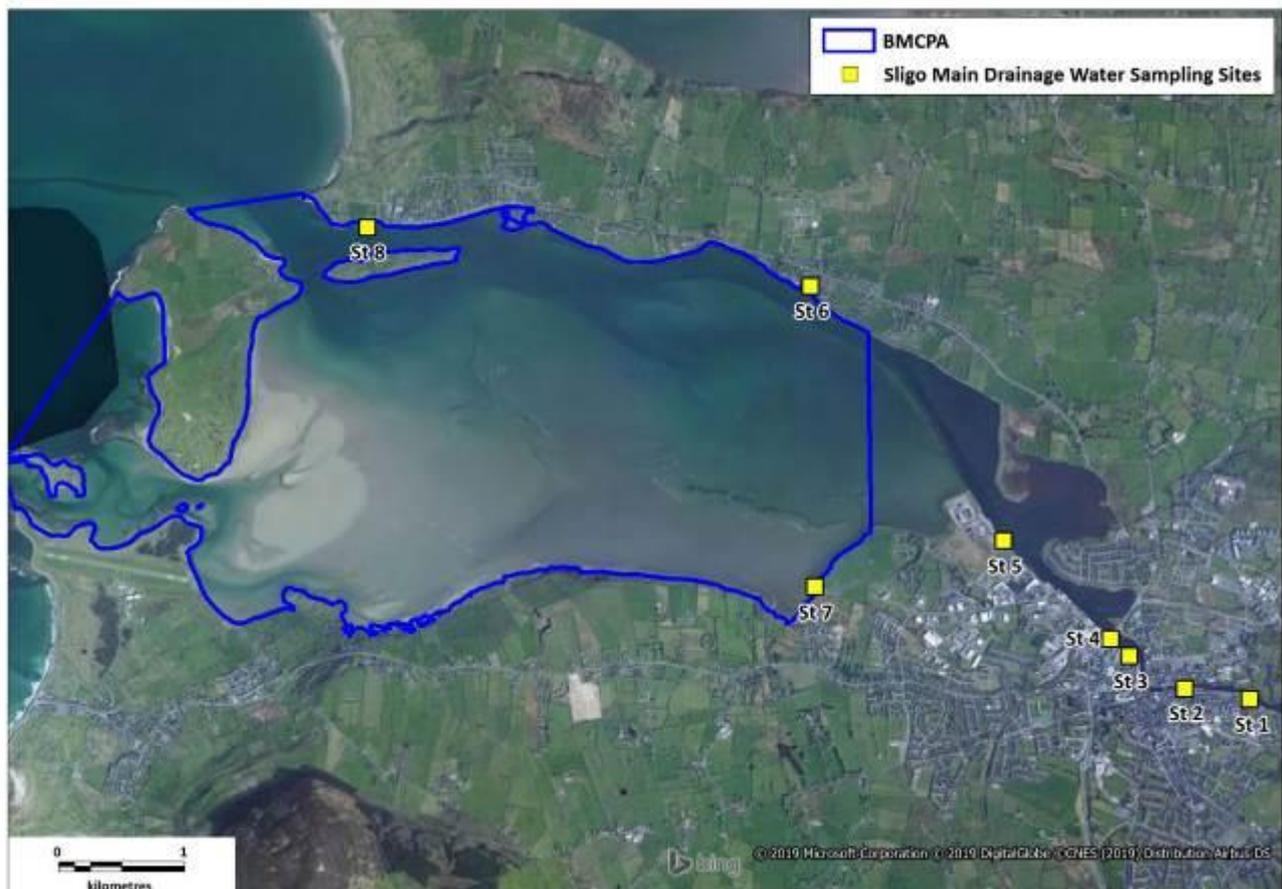
Figure 5.1: Sligo Main Drainage Water Sampling sites.

A significant difference was found between the *E. coli* results from the 8 stations (one-way ANOVA, $p = 0.0000003$, Appendix 2). A significant difference was observed between Station 1 in the Garavogue and Stations 3 (2 sample t-Test assuming equal variance, $p = 0.0001$, Appendix 2), 4 (2 sample t-Test assuming equal variance, $p = 0.0000002$, Appendix 2), 5 (2 sample t-Test assuming equal variance, $p = 0.000006$, Appendix 2), 6 (2 sample t-Test assuming unequal variance, $p = 0.0003$, Appendix 2) and 7 (2 sample t-Test assuming unequal variance, $p = 0.02$, Appendix 2).
