**Sanitary Survey Report
and
Sampling Plan
for Drumcliff Bay**

AQUAFAC International Services Ltd

The Sea Fisheries Protection Authority

July 2020

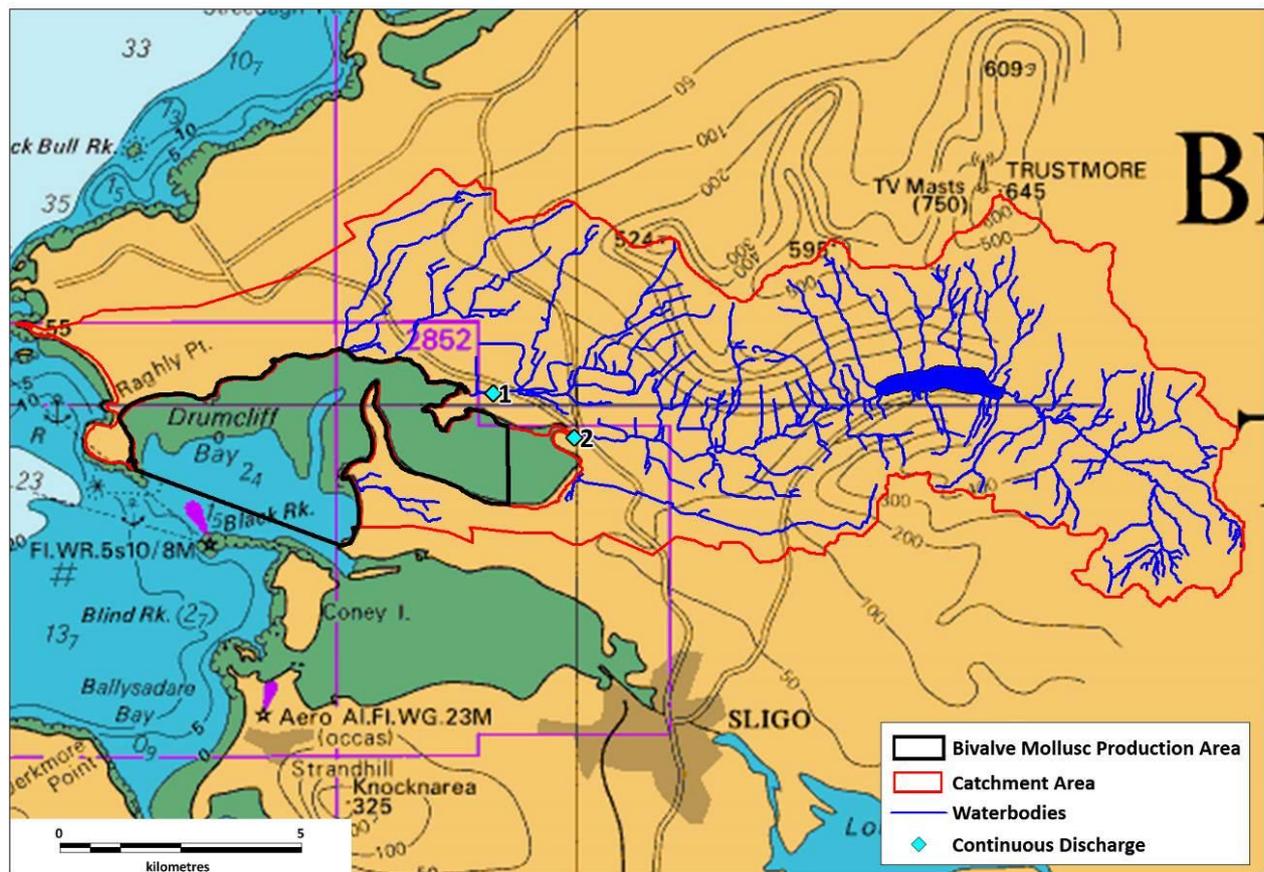
Figure 3.6: Continuous Discharges associated with the Wastewater Treatment Works within the Drumcliff Bay Catchment Area (Source: The EPA, 2019a).

As noted in Section 4.1.3 above, there are two waste water or sewage treatment works within the Drumcliff Bay catchment and these discharge into Drumcliff Bay. The Carney treatment plant serves a population equivalent of 2000 and treats waste to the tertiary level before discharging to the Carney River above the tidal limit. This plant is currently under capacity at 387 PE. The second treatment works, that of Drumcliff and Environs, treats waste to a secondary level and is a smaller unit catering for 150 persons. It too is also under capacity with a current population equivalent of 93. It is expected that both plants will be impacting contamination levels with the production area.

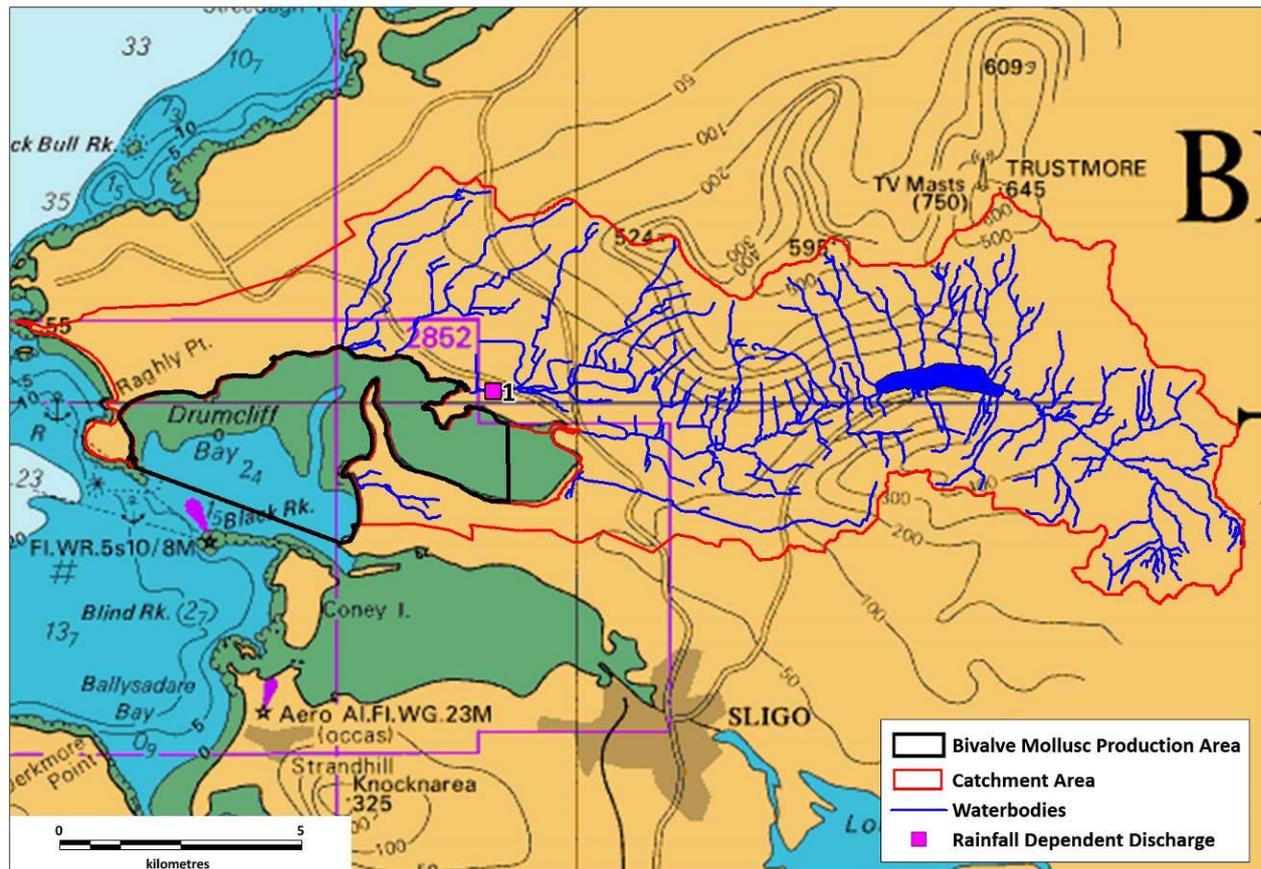
Figure 3.7: Rainfall Dependent Discharges associated with the Wastewater Treatment Works within the Drumcliff Bay Catchment Area (Source: The EPA, 2019a).

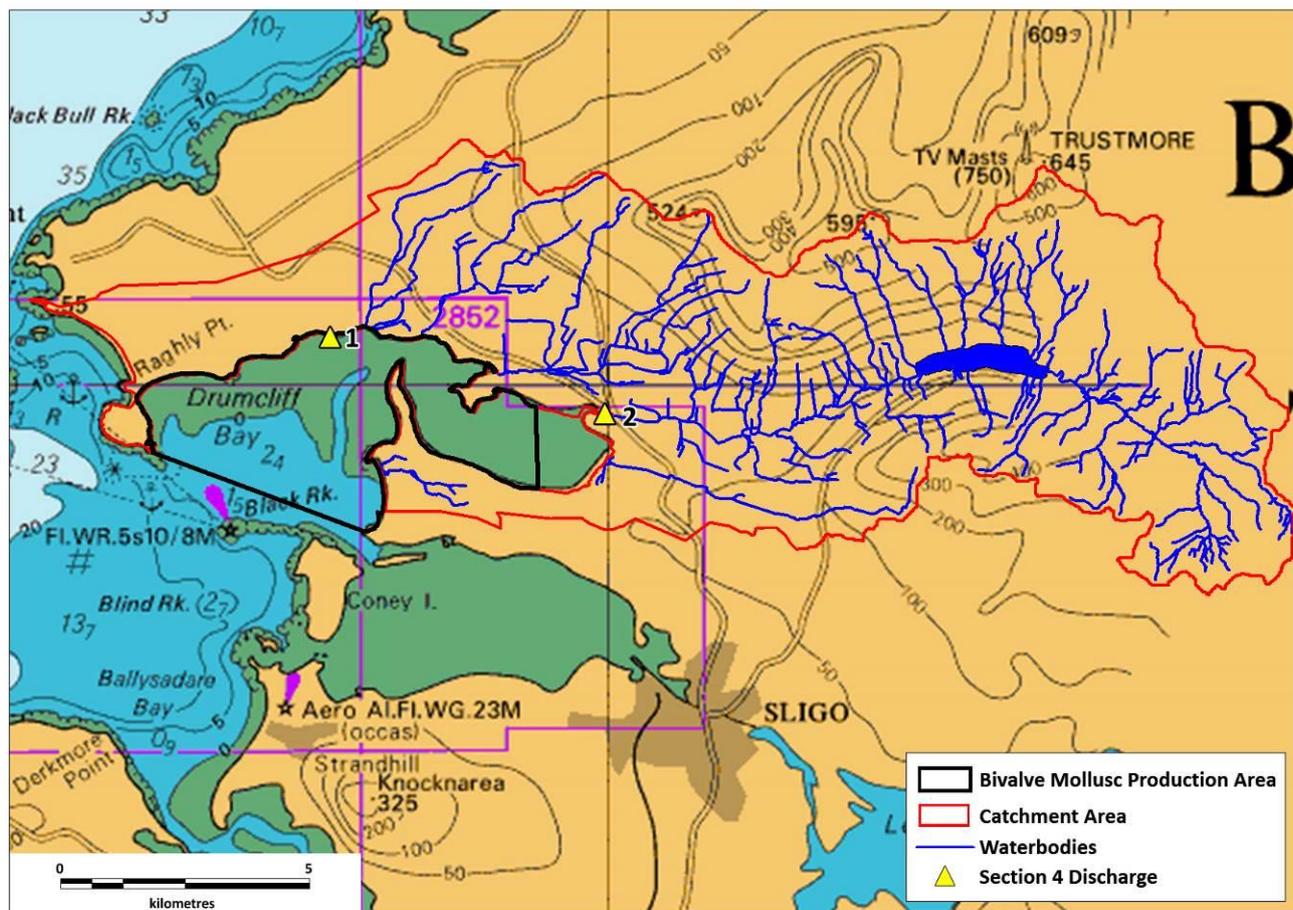
There are 2 Section 4 licences (see Figure 3.8) for the discharge of trade effluent (EPA, 2019d). Discharge 1 on the below map belongs to an oyster depuration/discharge centre and does not contain any domestic waste. The discharge to the east (Point 2) is that of a large restaurant/lounge business and includes waste water. No volumes or flows were available at the time of the report. Table 3.7 shows details of these Section 4 licences. Specifics of the discharges are unknown.

Figure 3.8: Section 4 discharges within the Drumcliff Bay Catchment Area (Source: (EPA, 2019c; EPA, 2019d).

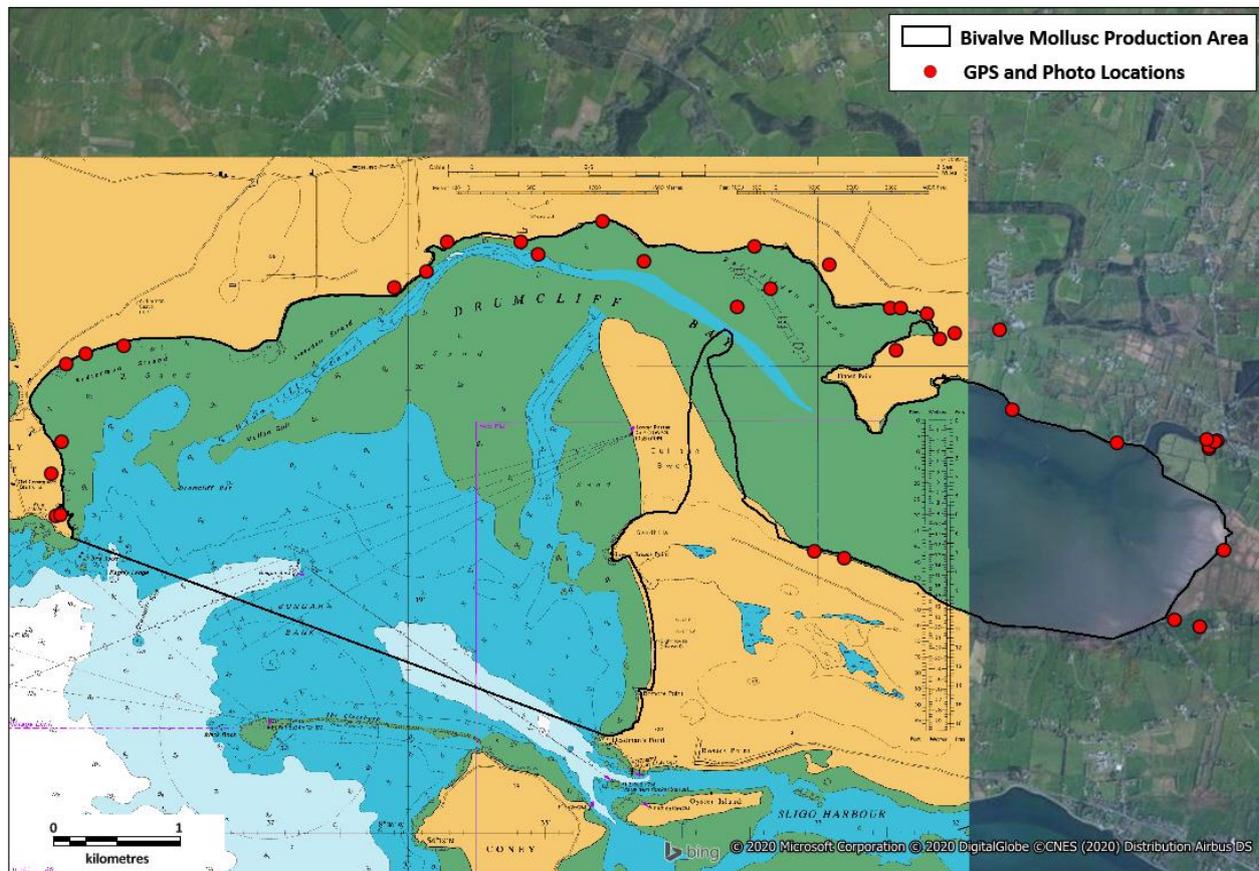
Figure 3.20: Locations of GPS and Photograph Sites.

Figure 3.20 shows the locations of all features observed during the shoreline survey. In total 32 features were identified, of which 7 rivers/streams were identified, 9 drains, 2 WWTP, 2 discharge pipes, 1 WWTP discharge, 1 intake pipe, 1 lagoon discharge, 1 harbour and 8 were in relation to landuse (bird usage, agriculture). Figures 3.21 to 3.32 show aerial imagery of the location of the features and Figures 3.33 and 3.34 shows images of most of these features. Table 3.12 details all features identified and the numbering used is cross-referenced to Figures 3.21 to 3.34.

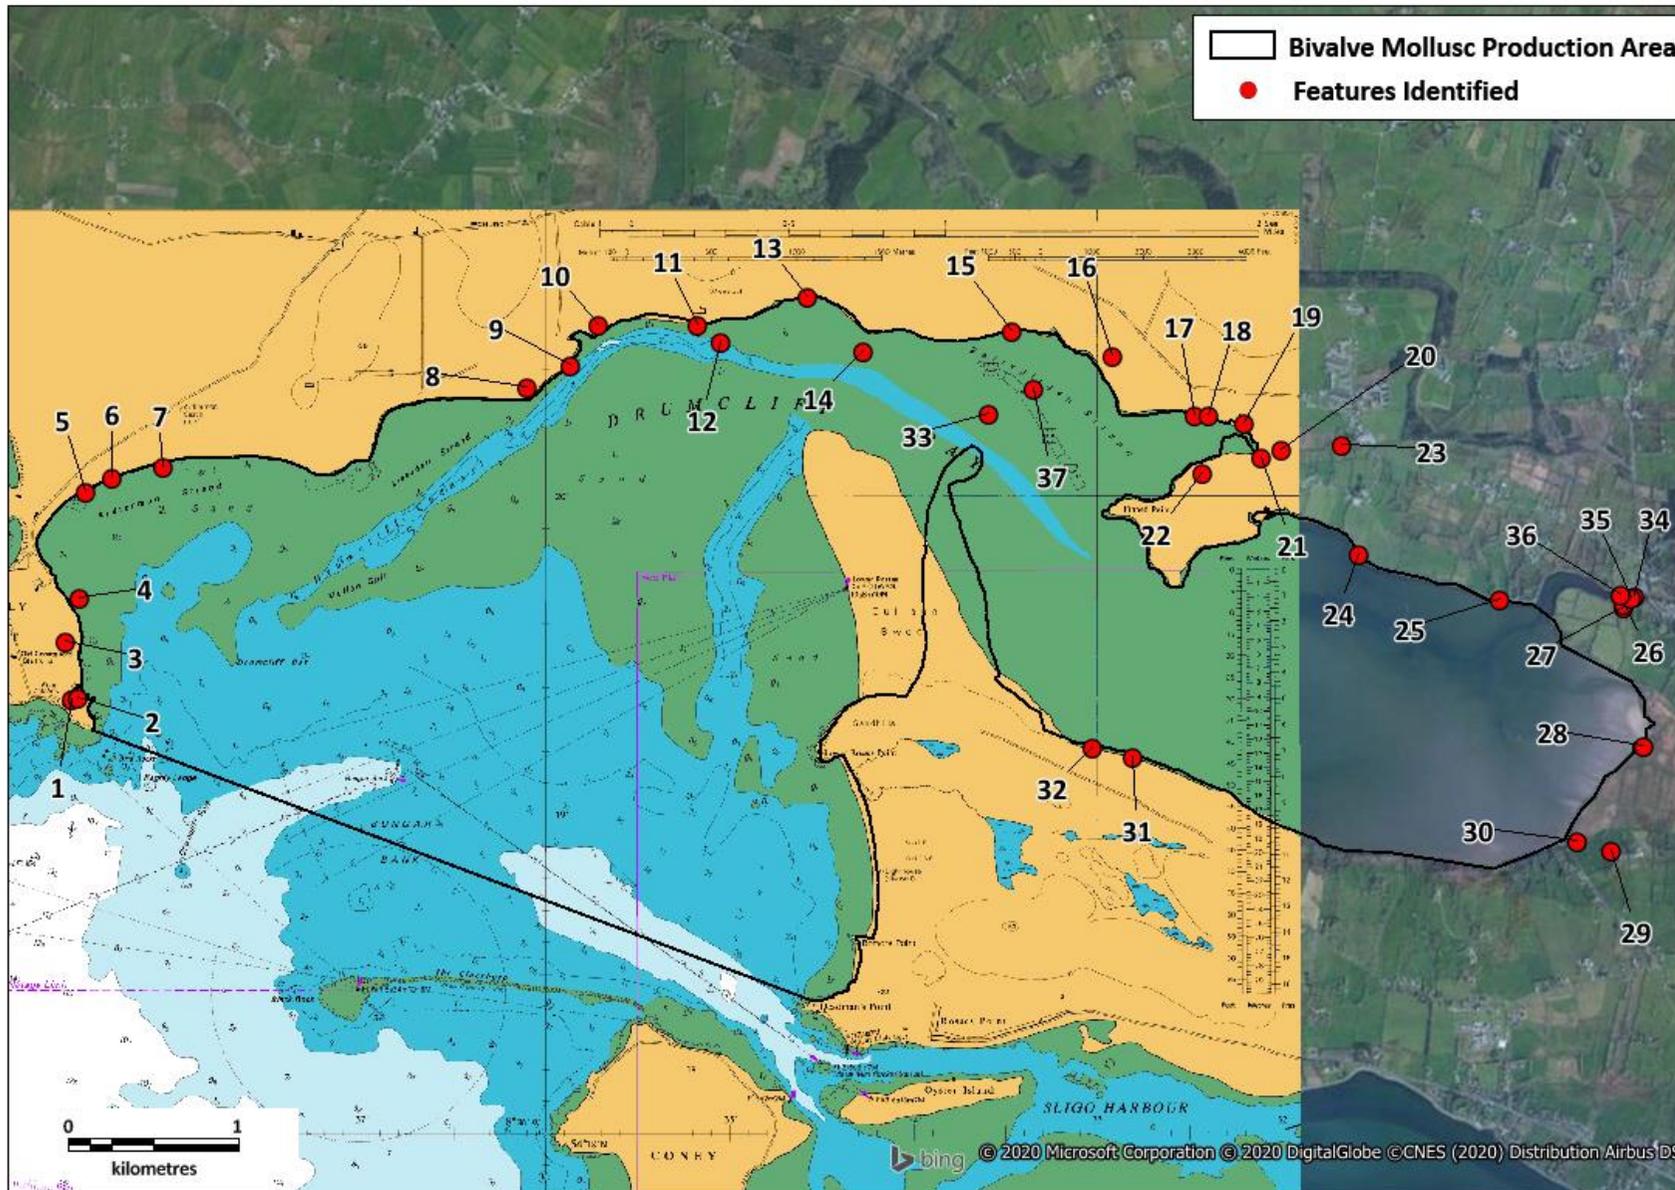
Figure 3.21: All features (numbering cross-reference to Table 3.12) identified during the shoreline survey.

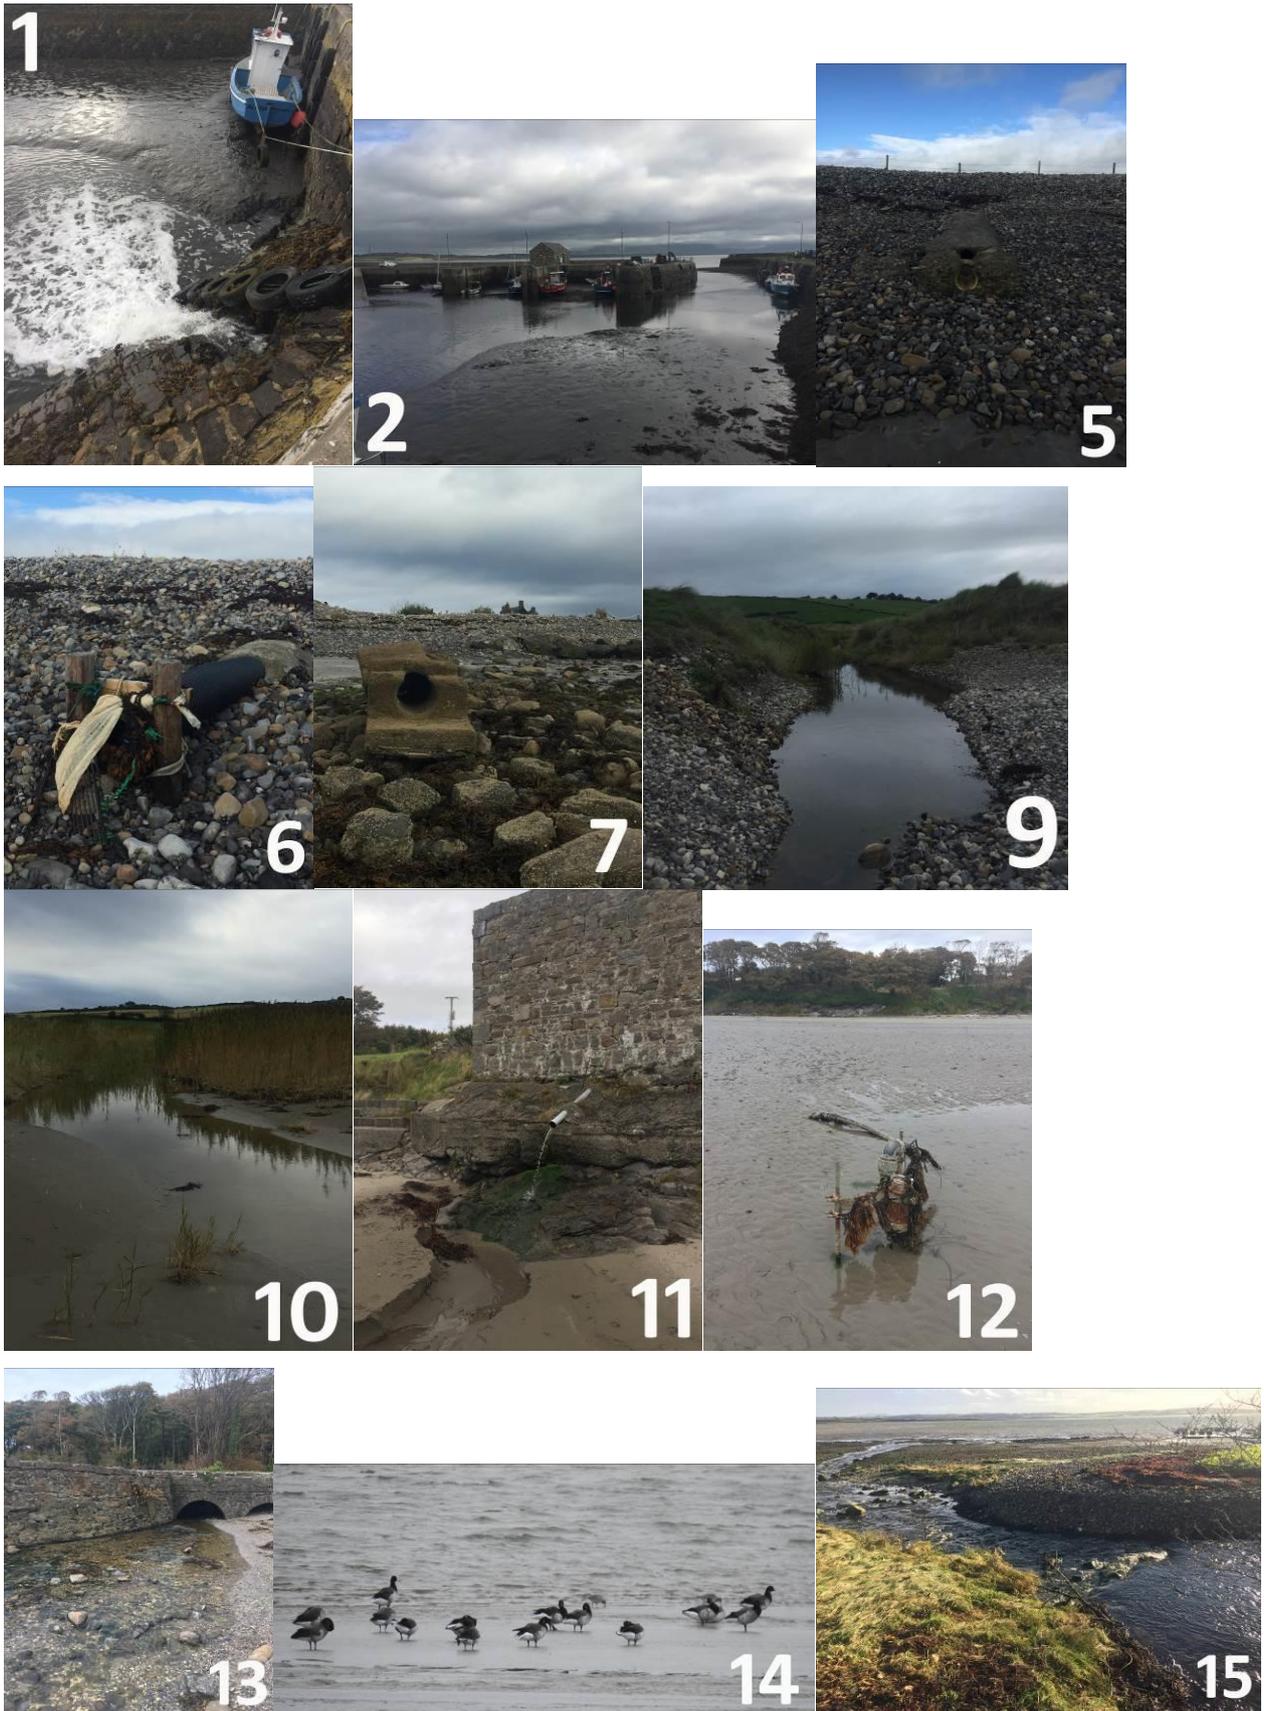
Figure 3.34: Features 1-15 located during the shoreline survey. Refer to Figures 3.21-3.33 for site locations.

In terms of physical infrastructure the two wastewater treatment plants at Carney and Drumcliff were noted with two discharges pipes from the later encountered entering the estuary immediately adjacent. The discharge point from the Carney plant was not visible during the survey but is believed to enter the river downstream of the plant. A man hole cover was also noted on the bank opposing the Drumcliff plant but no obvious discharge point was discovered and it is unclear if this is associated with the nearby Section 4 discharge licence or is part of the Drumcliff plant pipework.

A number of other pipes were encountered during the shoreline survey and these were identified as land drainage pipes, a cluster being noted draining pasture land at Ardtermon Strand.

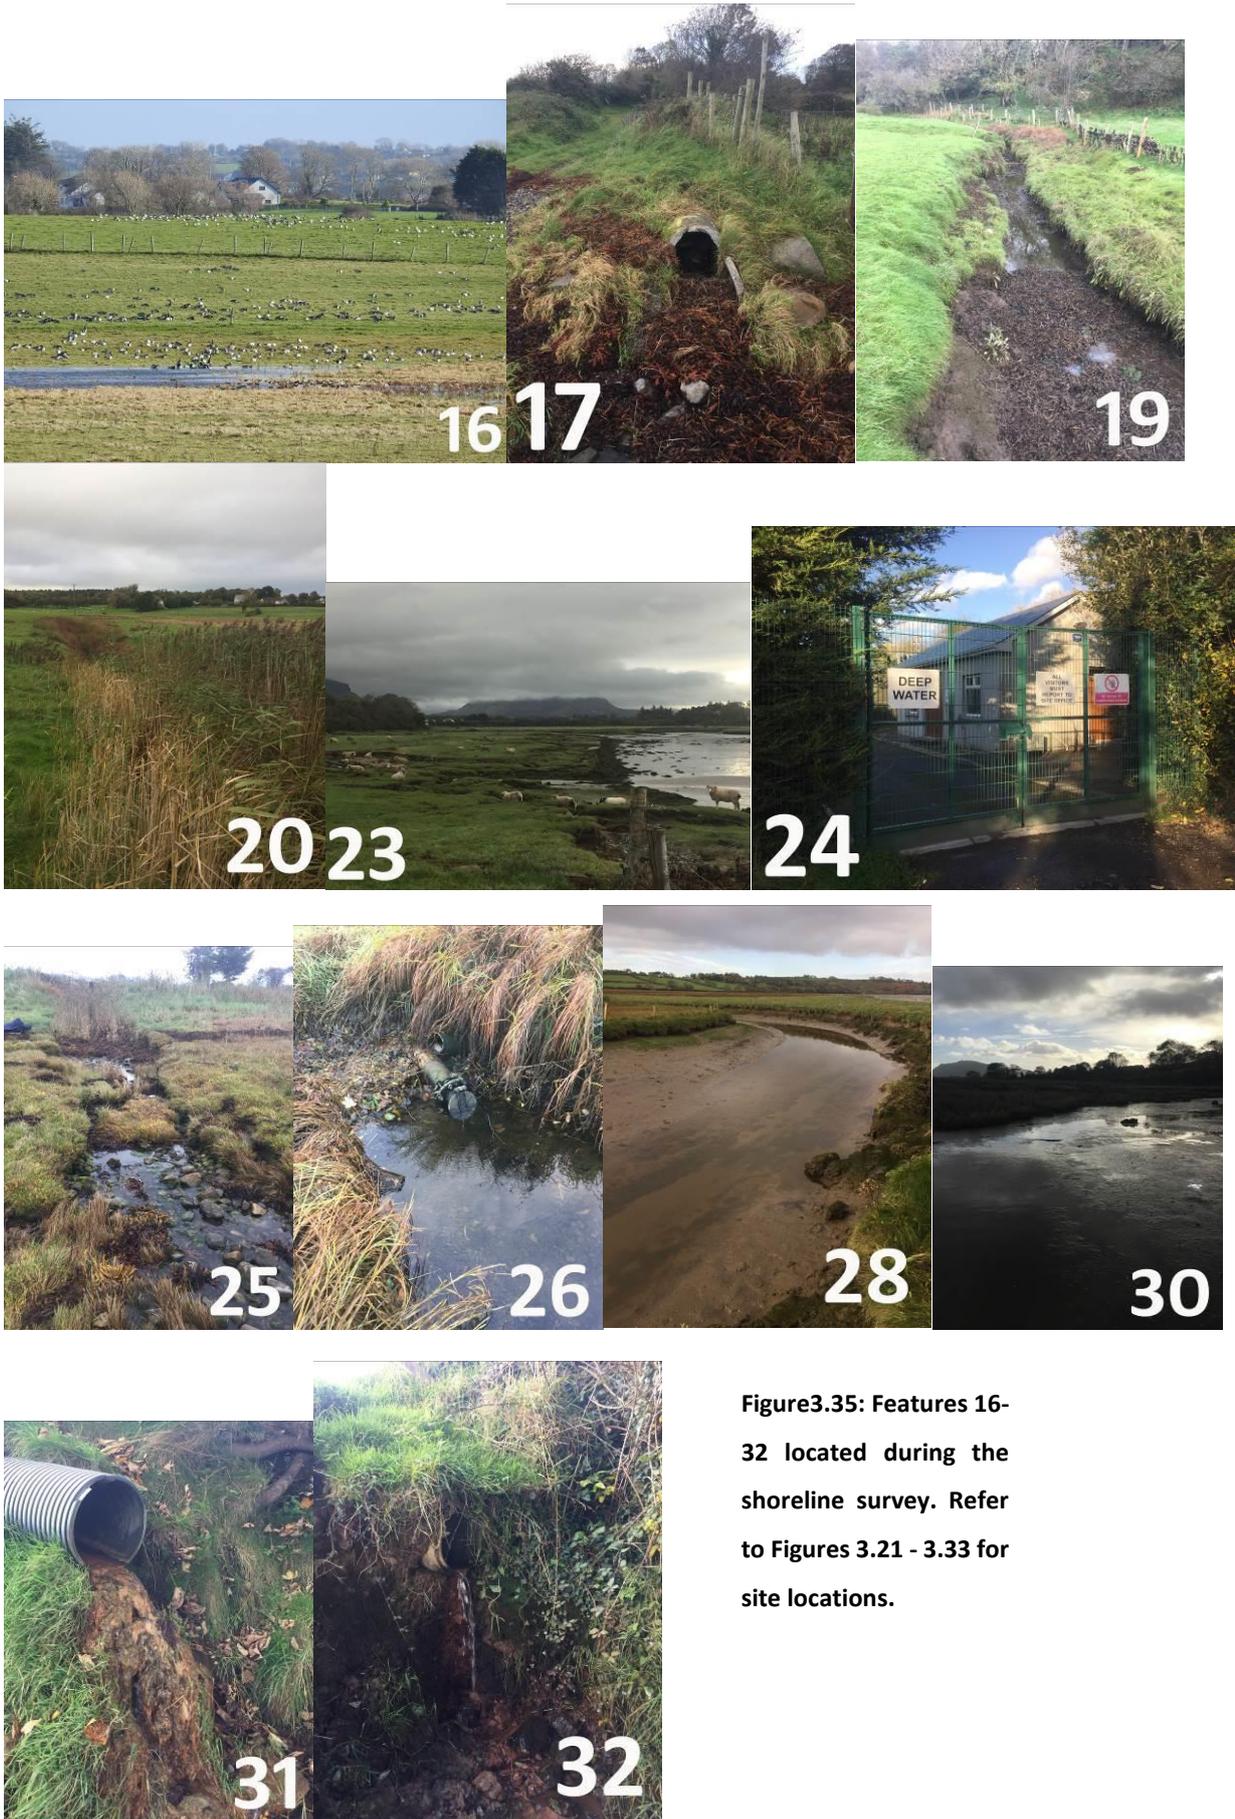
Figure3.35: Features 16-32 located during the shoreline survey. Refer to Figures 3.21 - 3.33 for site locations.

Areas of pasture land were noted during the shoreline survey but numbers of agricultural animals encountered were low. Sheep though were noted feeding directly on the foreshore at the mouth of the Carney River. Cows (10 approx) were seen north of Raghly Point and another group (20 approx) were noted on ground near the shoreline at Kintogher.

In terms of wild animals large number (150 approx.) of mixed geese and wading birds was noted at the western end of Ardtermon Strand. A large number of barnacle geese (300 approx) were also encountered during the survey in the pasture ground at Ballygilgan Nature Reserve. A small seal haul out was also noted opposite the oyster farms at Ballygilgan, a group of seals (10 approx.) were seen there during the survey.

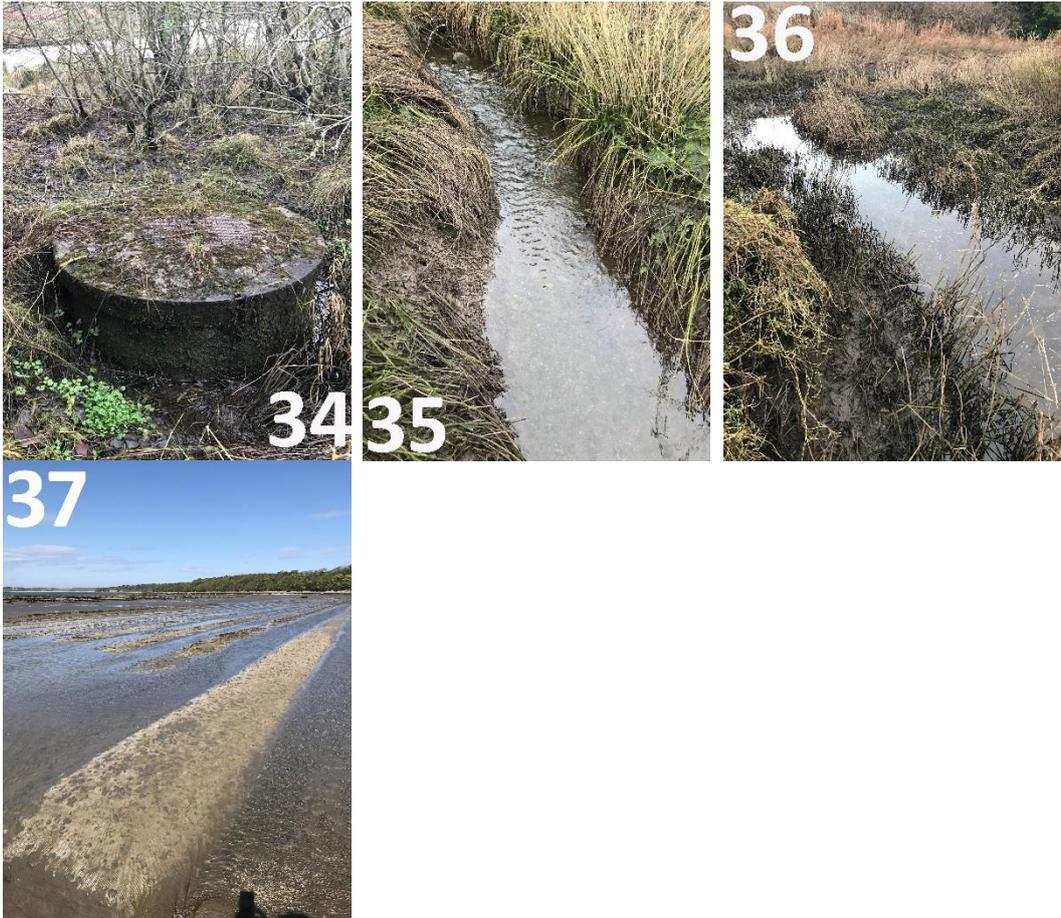
Figure 3.36: Features 34-37 located during the shoreline survey. Refer to Figures 3.21-3.33 for site locations.

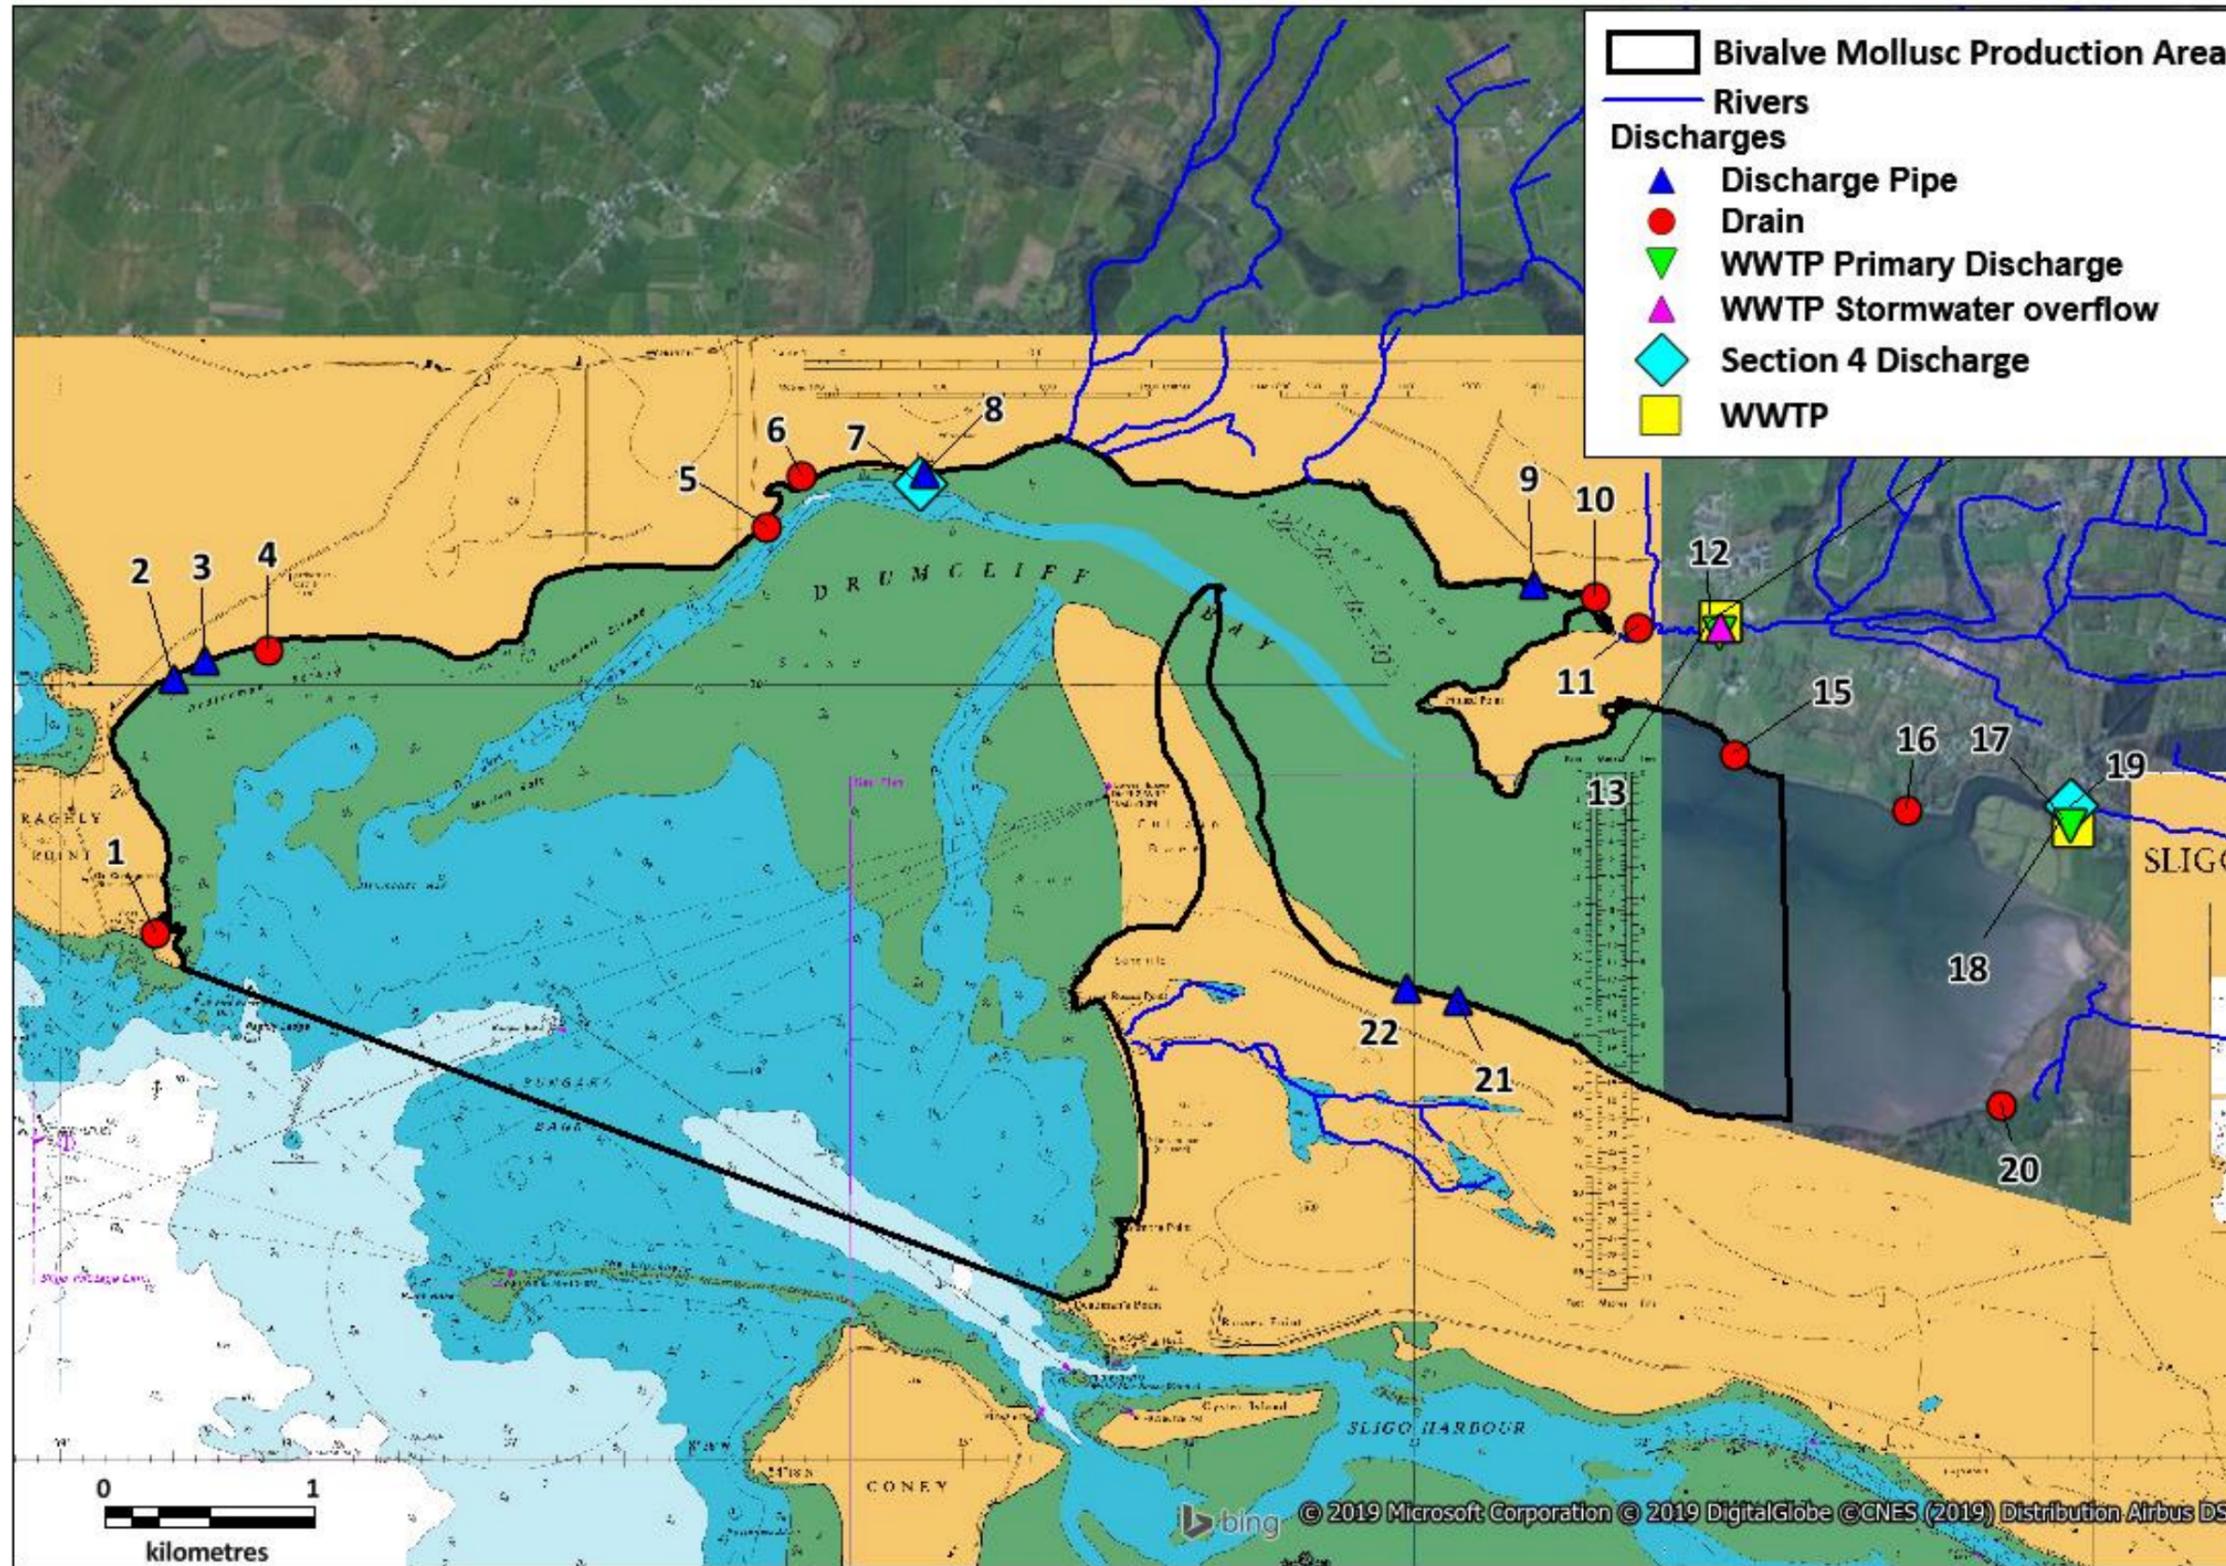
Figure 3.38: Locations of all discharges within the Drumcliff Bay Catchment Area.

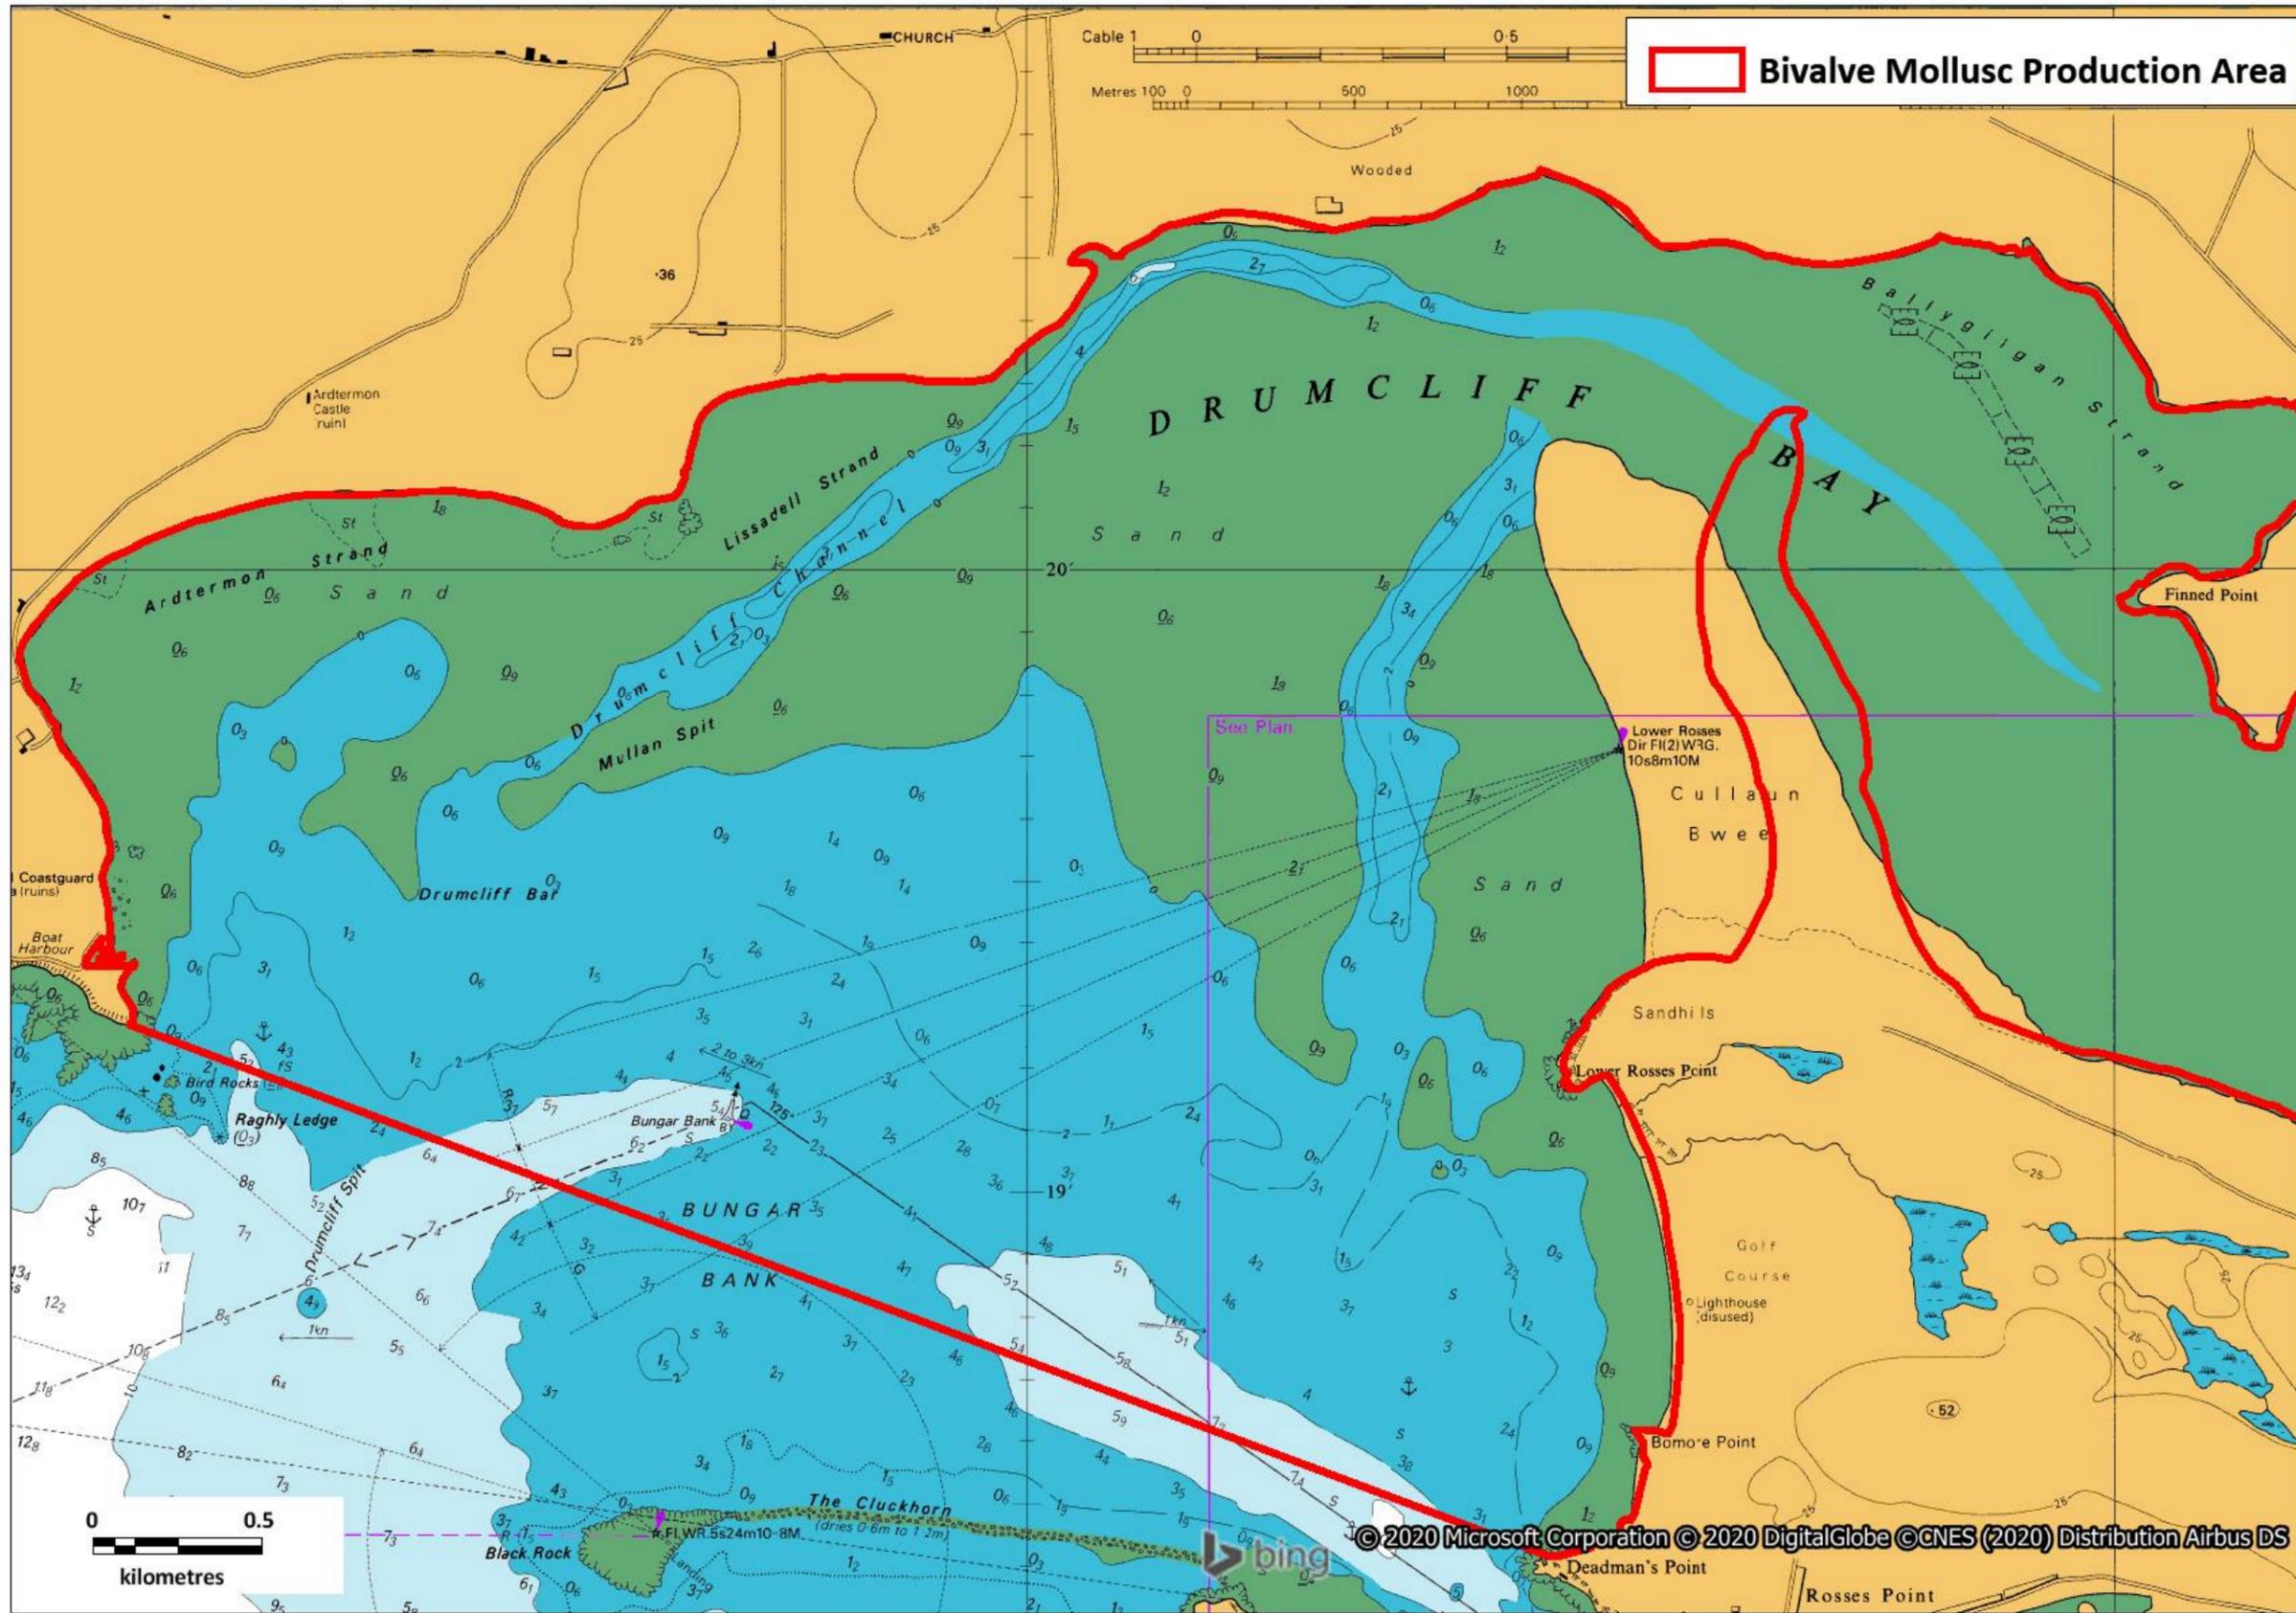
The majority of the bay is made up of intertidal sand and mudflats. The admiralty chart bathymetry for the area (see Figure 4.1), although collected in the early 1840's, is still regarded as relatively accurate by local fish farmers (Kelly, pers. comm.). INFOMAR LIDAR survey data (see Figure 4.2) was also examined to describe the bay's bathymetry. A channel runs from the Drumcliff River along the north of the bay past Fined Point at which point it turns up north-westerly and passes through the narrow passage between the spit and the north shore. After this point the channel turns south-westerly and travels down the middle of the outer bay to about half way between Raghly Point and Rosses Point. Depths in the outer bay range from 0 to 8m while all of the inner bay is drained at low water except for the main channel. Depths in the channel range from 1 to 7m.

Figure 4.1: Depths in Drumcliff Bay (Source: Admiralty Chart 2852).

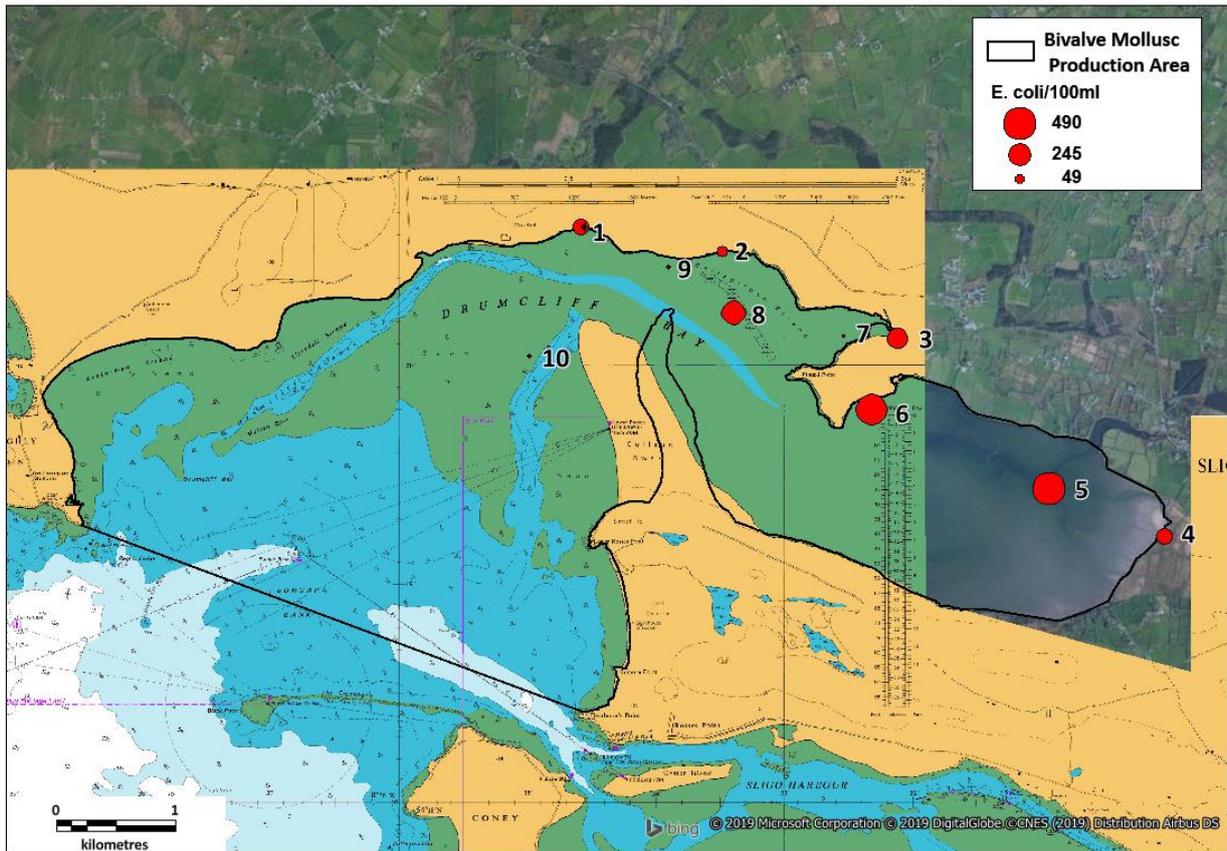
Figure 5.11: Location and magnitude of E. coli results from the shore survey.

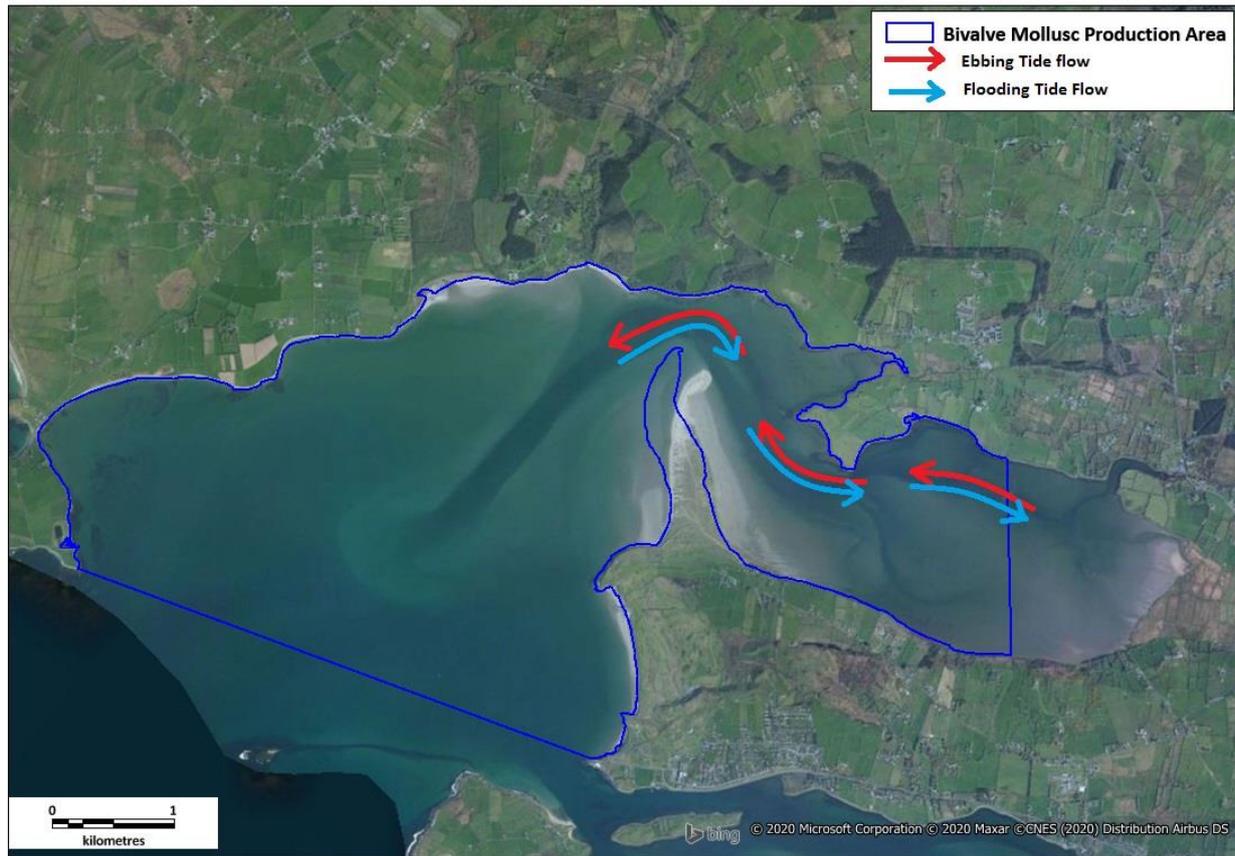
As mentioned above sea water sampling data suggest contamination levels decline the further seaward the channel flows. Salinity levels within the outer bay (WFD sampling site) and the middle parts close to the sand spit (SWD sampling station) were found to be quite high indicating that the freshwater influence of the Drumcliff and Carney rivers dissipates quite quickly.

Figure 6.1: Tidal flows in Drumcliff Bay.
