**Sanitary Survey Report
and
Sampling Plan
for Drumcliff Bay**

AQUAFAC International Services Ltd

The Sea Fisheries Protection Authority

July 2020

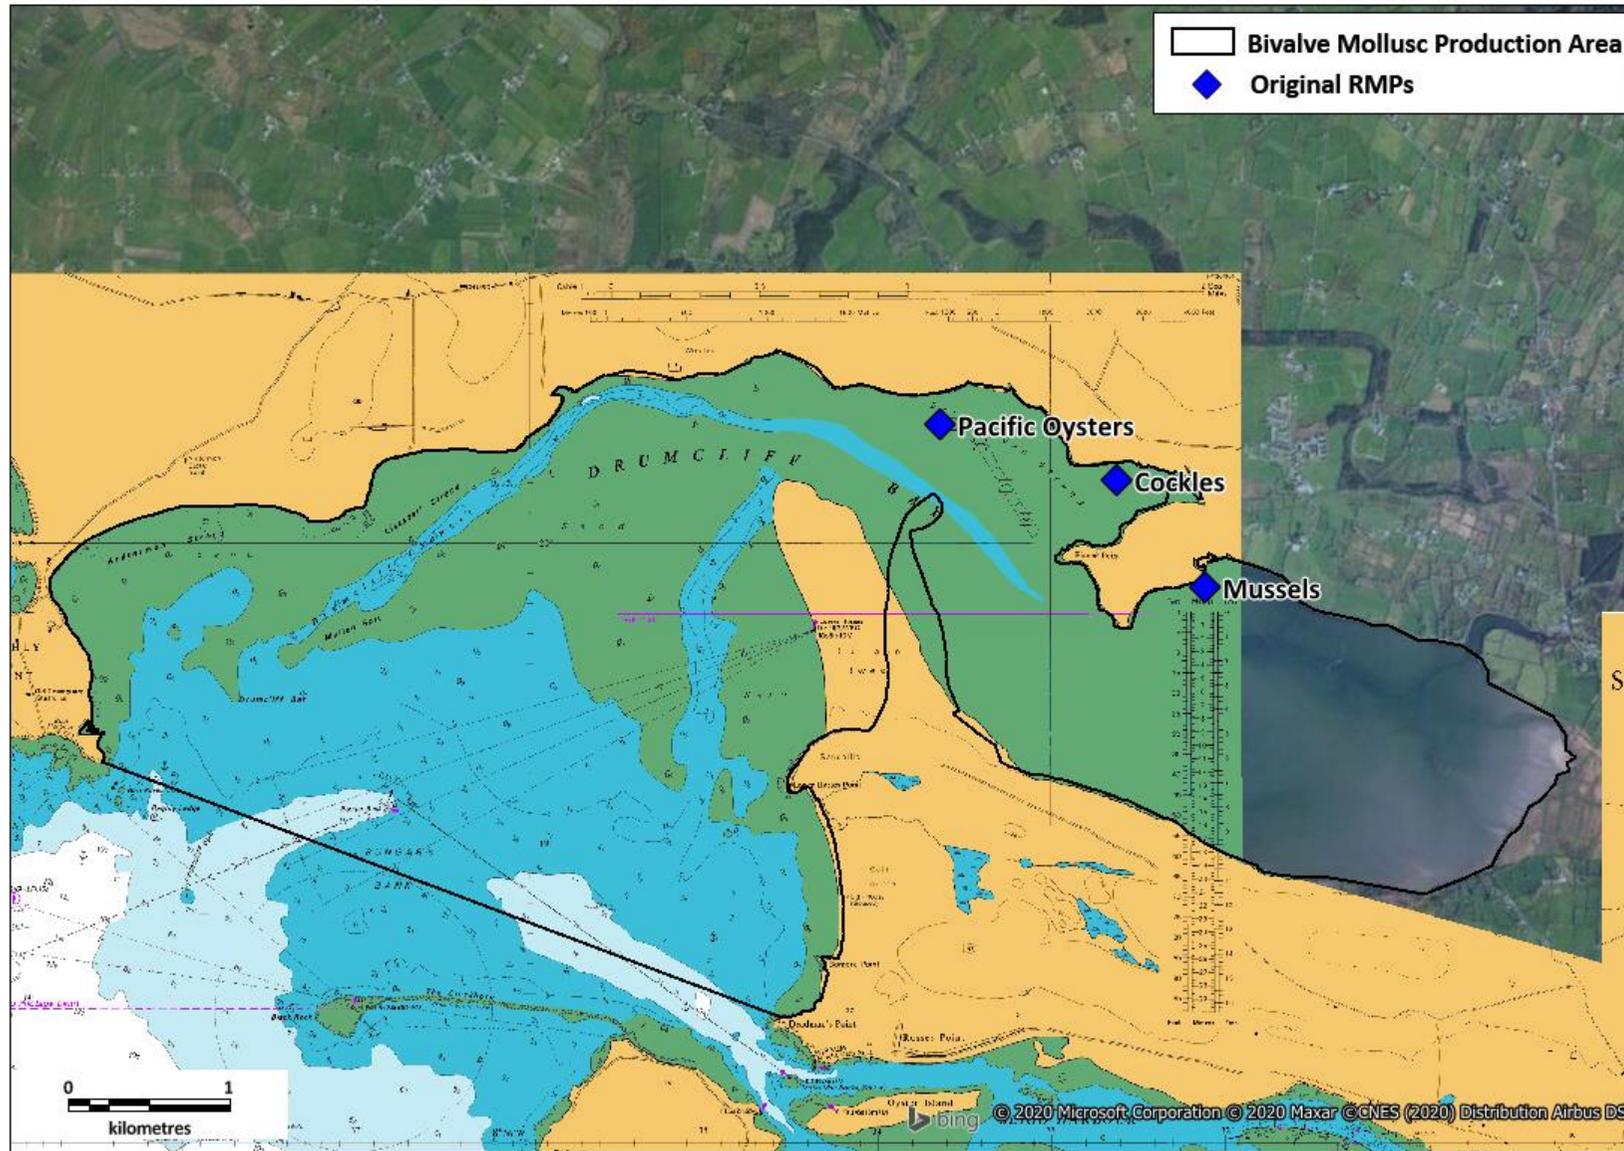
Figure 8.2: Bivalve Mollusc Classified Production Area within Drumcliff Bay with old RMP locations displayed.

It is recommended that the original mussel RMP remains in place and active. Figure 8.1 shows the locations of the new RMPs and Figure 8.2 shows the original locations of the RMPs.
