**Sanitary Survey Report and Sampling Plan for
Bantry Gearhies, Co. Cork**

Produced by

AQUAFACT - APEM Group

April 2024

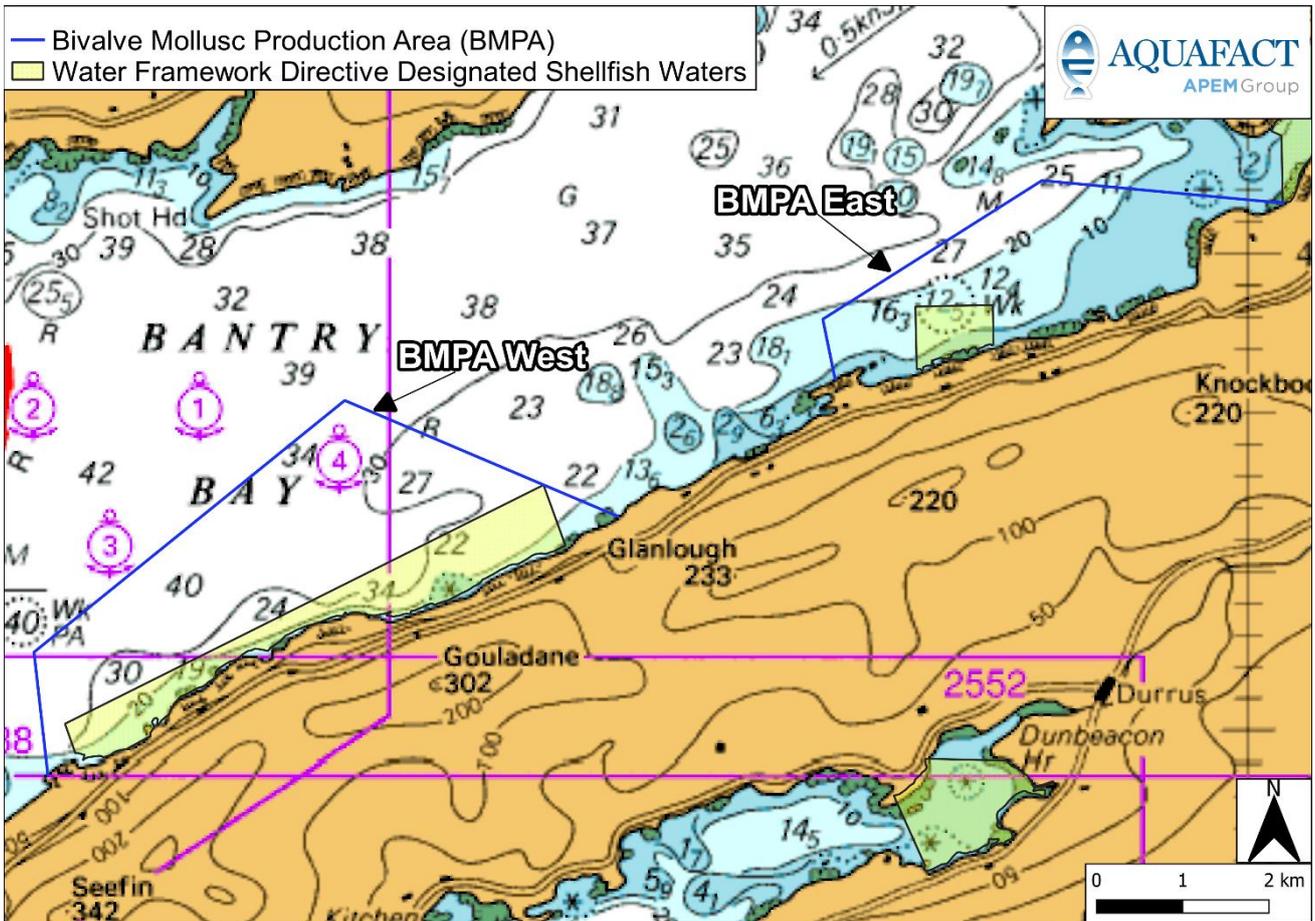
Figure 3-2: Bantry Gearhies bivalve mollusc production areas (BMPAs) east and west in Bantry Bay, Co. Cork.

coli levels discharging (see section 7.2 for details on these outfalls; Figure 7-35 map ID 20-22); the coordinates for the two BMPAs are detailed in Table 3.1.

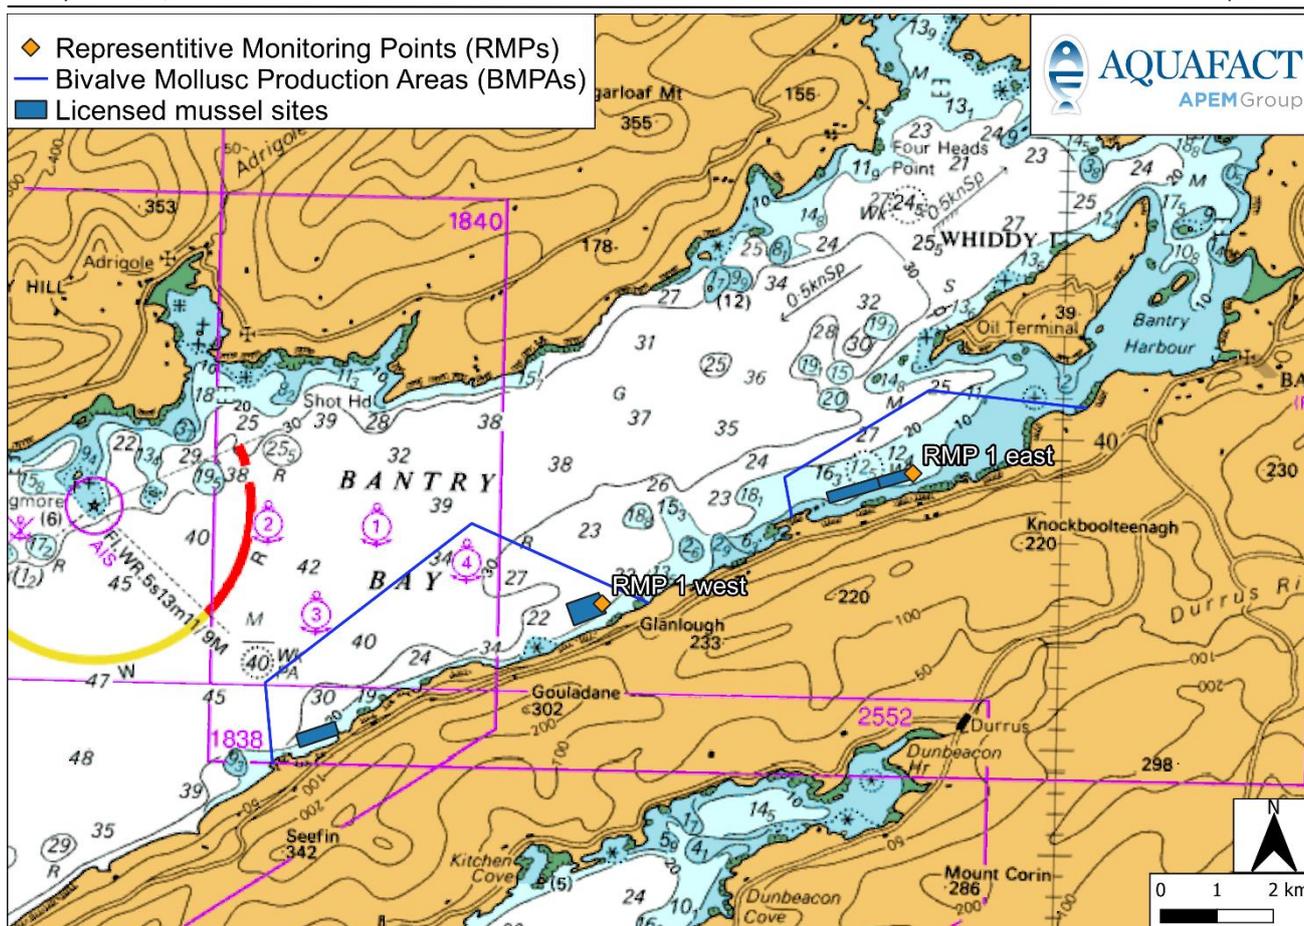
Figure 6-1: Representative Monitoring Points (RMPs) for blue mussel in the Bantry Gearhies bivalve mollusc production areas (BMPAs) east and west.

It is recommended that RMP 1 east be situated on the north-eastern side of site T05/433 within the Bantry Gearhies east BMPA (**Figure 6-1** and **Table 6.1**).

Within Bantry Gearhies west BMPA, RMP 1 west is being proposed on site T05/430A (**Figure 6-1** and **Table 6.1**). There are numerous piers, slipways, and ports to the northeast of the T05/430A site, as noted from the desktop survey (**Figure 7-18**). The Corine land use type along the coastline adjacent to this mussel site is mainly land principally occupied by agriculture, with significant areas of natural vegetation (**Figure 7-7**). There are many rivers by which contamination from this landscape and these features could enter the Bantry Gearhies west BMPA (**Figure 7-34**). These rivers are part of the Fahane River sub-basin (**Figure 3-3**). Groundwater vulnerability is categorised as being rock at or near surface or karst with intermittent patches of groundwater with extreme vulnerability status (**Figure 7-9**). The water sample with the highest *E. coli* concentration from the bacteriological survey (6,488 *E. Coli* (MPN/100 ml) from Station 9; **Figure 9-1**) is located upstream of the

One RMP for each of Bantry Gearhies BMPA east and west is recommended for monitoring *E. coli* levels in mussel samples.

A minimum of 15 individual blue mussels of market size (minimum 4 cm shellfish length) are required to be sampled monthly^{4,22}. Flesh samples should be taken within the top one metre of the water column, and as close to the surface as possible, in order to obtain a representative sample of the *E. coli* levels in the production areas. Flesh samples should be taken within a maximum distance of 100 m from the RMPs²² (**Table 6.1**). Upon establishment of the classified production areas for blue mussels, and considering that harvesting can potentially take place year-round, monthly sampling will be required throughout the entire year. The SFPA is the competent authority responsible for implementing this plan.

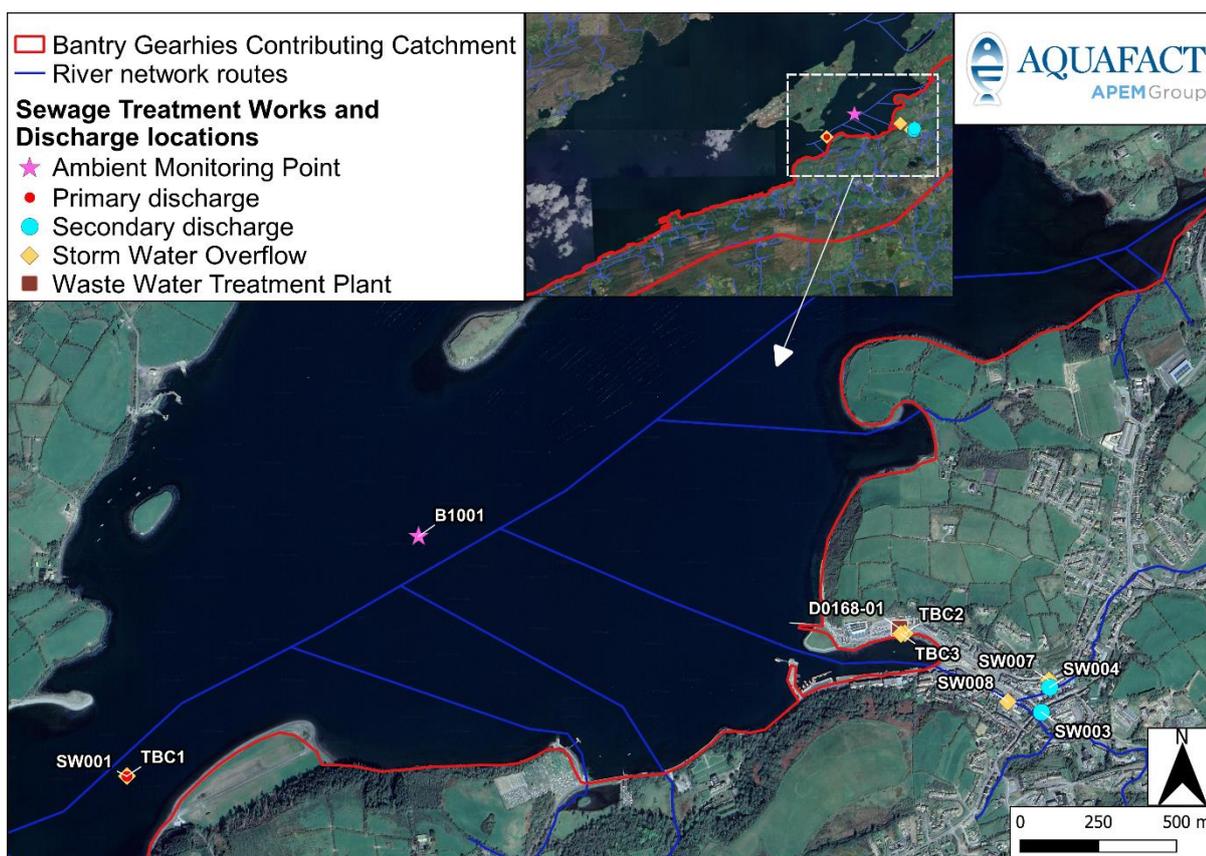
Figure 7-5: Locations of WWTP and discharge locations in Bantry Gearhies contributing catchment. Names cross-referenced to Table 7.3.

*It should be noted that while SW08 is reported as being a storm water overflow in the 2022 Bantry AER, it was recorded as a primary discharge point, licence code SW001, in a 2021 EPA wastewater discharge licence audit report²⁹.

There were five storm water overflows identified in the 2022 AER for Bantry as being part of the Bantry WWTP (Uisce Éireann, 2022); three of these were noted in the AER as needing to be confirmed by Uisce Éireann (**Figure 7-5; Table 7.3**). The five storm water overflows were deemed as not meeting the criteria of the Department of Environment, Housing, and Local Government³⁰, however all five were ranked as having a low significance. Only two of these overflows are monitored, one of which is recorded as having a total discharge volume of 101,926 m³ in 2022 (Uisce Éireann, 2022).

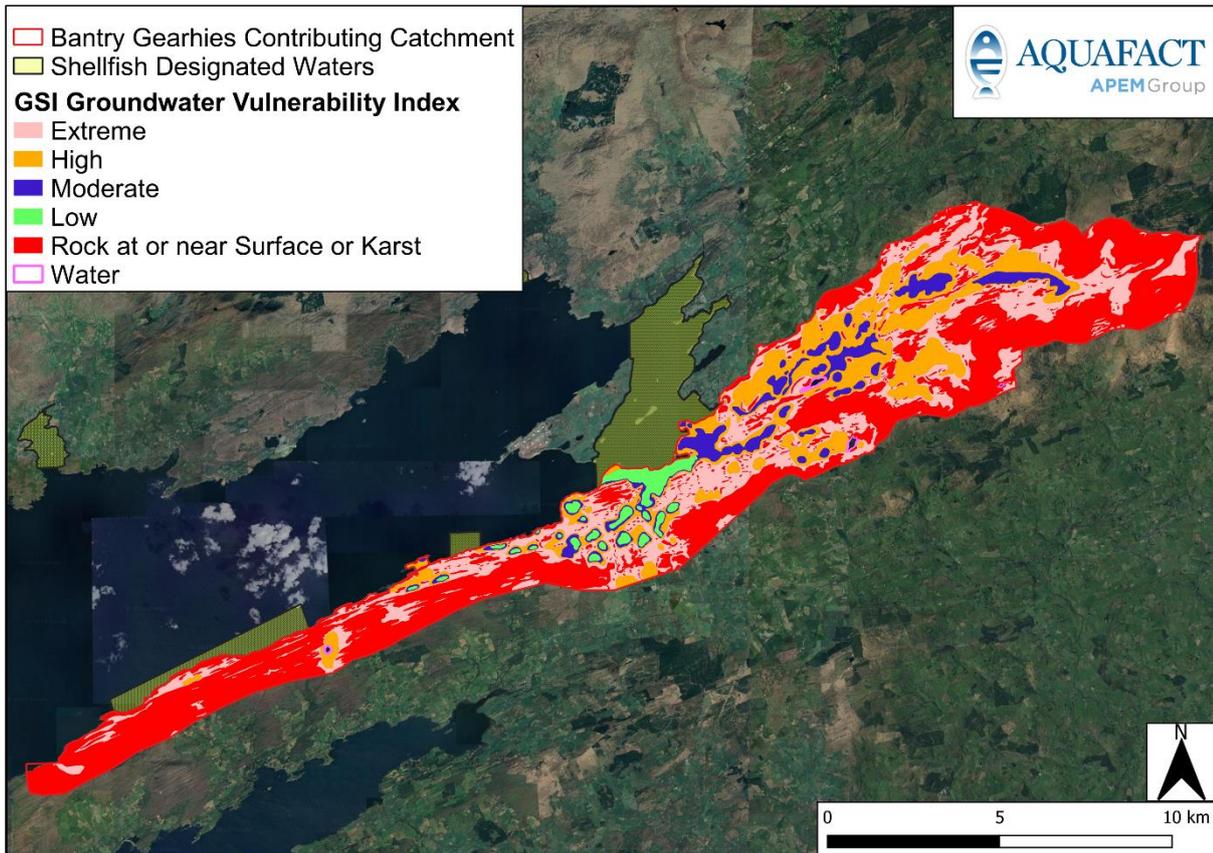
Figure 7-9: Geological Survey of Ireland (GSI) groundwater vulnerability within Bantry Gearhies contributing catchment. Contains Irish Public Sector Data (Geological Survey Ireland) licensed under a Creative Commons Attribution 4.0 International (CC BY 4.0) licence.

Furthermore, the Geological Survey of Ireland groundwater data viewer shows areas of high to extreme groundwater vulnerability occur within the contributing catchment, and adjacent to the Bantry Gearhies east and west BMPAs there is predominantly rock at or near the surface or karst (**Figure 7-9**). These areas of high vulnerability primarily coincide with pastures but also overlap with peat bogs and agricultural land. In such areas S.I. No. 113/2022 states that “soiled water”³⁵ cannot be spread on land if the quantity exceeds 25,000 L/ha in a 42-day period or at an irrigation rate greater than three mm/hr on land of thickness less than one metre. While the levels of slurry and soiled water spreading were not readily available for Bantry Gearhies contributing catchment at the time of writing, the fact that 53% of the land is comprised of pastures and agricultural land gives an indication of the potential levels of spreading in the contributing catchment and potential discharge levels to groundwater and, subsequently, the DSW in the bay.

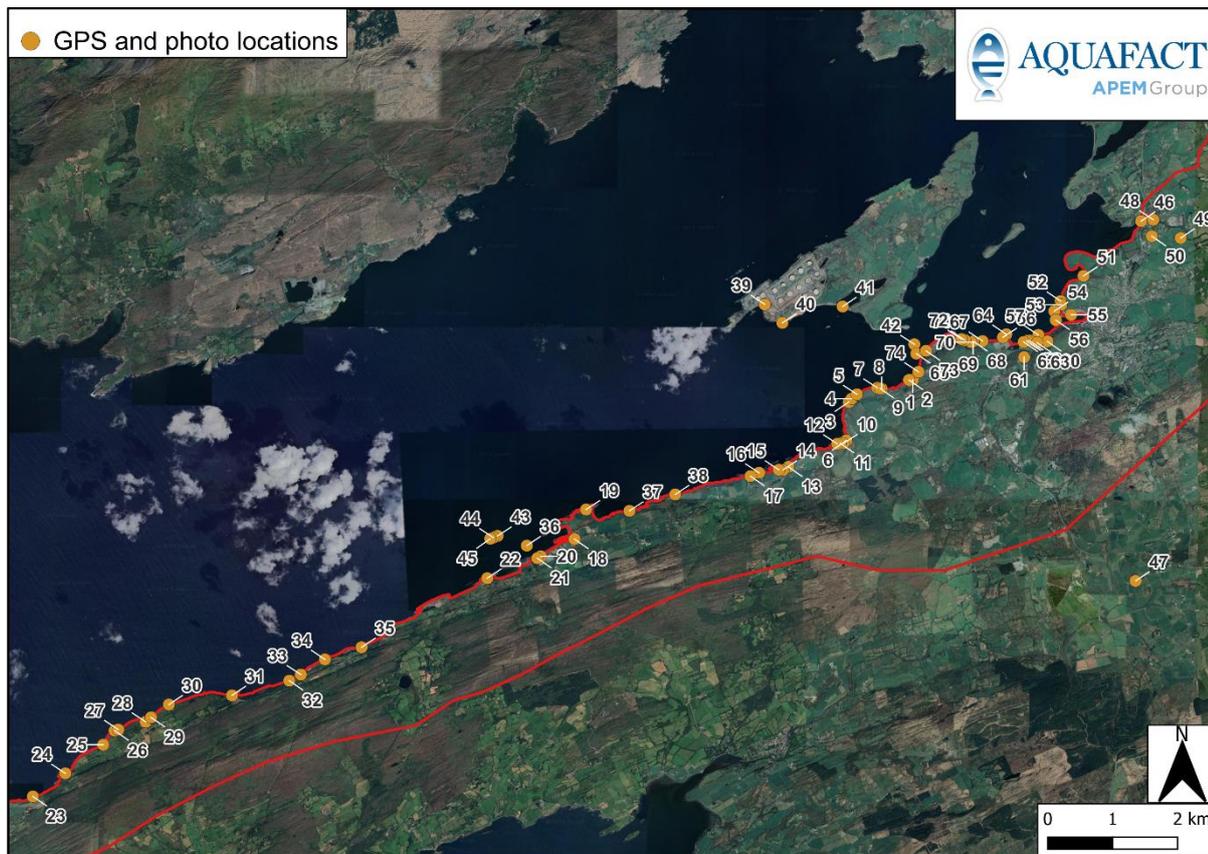
Figure 7-20: Locations of GPS and photograph sites from the shoreline survey (numbering cross-referenced to Table 7.10).

There were three piers, two ports, and eight potential slipways noted during the desktop survey. The shoreline survey validated four of these; two piers (map IDs 54 and 56; **Figure 7-20**), one slip (map ID 64; **Figure 7-20**), and one jetty were confirmed by the shoreline survey (map ID 65; **Figure 7-20**). **Section 4.9** details all of the shoreline survey observations.

Papadakis *et al.*, (1997) found significant correlations between the number of swimmers present on beaches and the presence of pathogenic bacteria in Greece. In 2007, Elmir *et al.*, showed the role of human skin as an intermediate mechanism of pathogen transmission to the water column. However, as there are no monitored beaches or bathing water locations along the coastline of the Bantry Gearhies east and west production areas, the numbers of swimmers are likely to be low and so will not impact on the bacteriological quality of the bay²⁷. Two beaches were identified by the shoreline survey (map IDs 6 and 72; **Figure 7-20**).

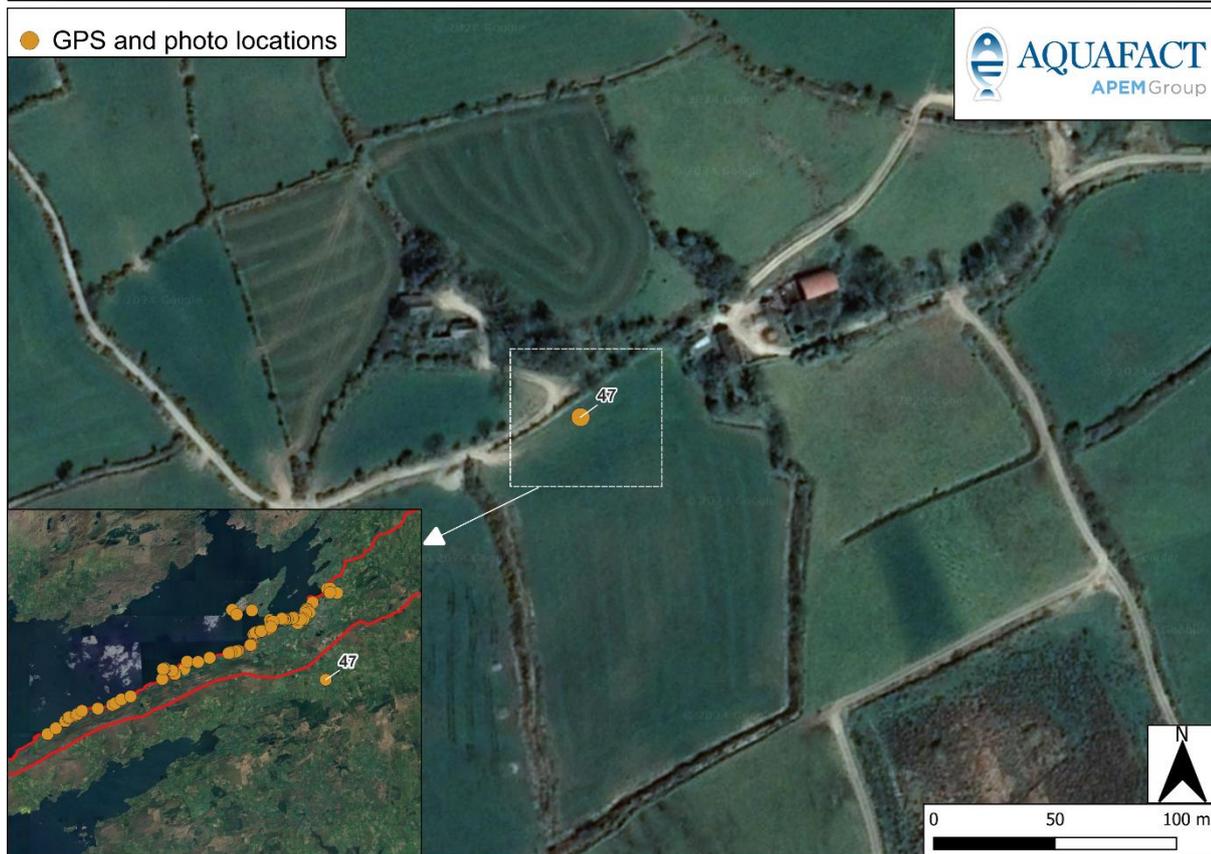
Figure 7-30: Feature 47 identified during the shoreline survey (numbering cross-referenced to Table 7.10). Note that feature 47 was described in the shoreline observations as being adjacent to features 46 and 48, however the GPS coordinates for feature 47 place it outside of the contributing catchment. Therefore, an error was made in recording the coordinates of this feature, consequently it can be discounted.

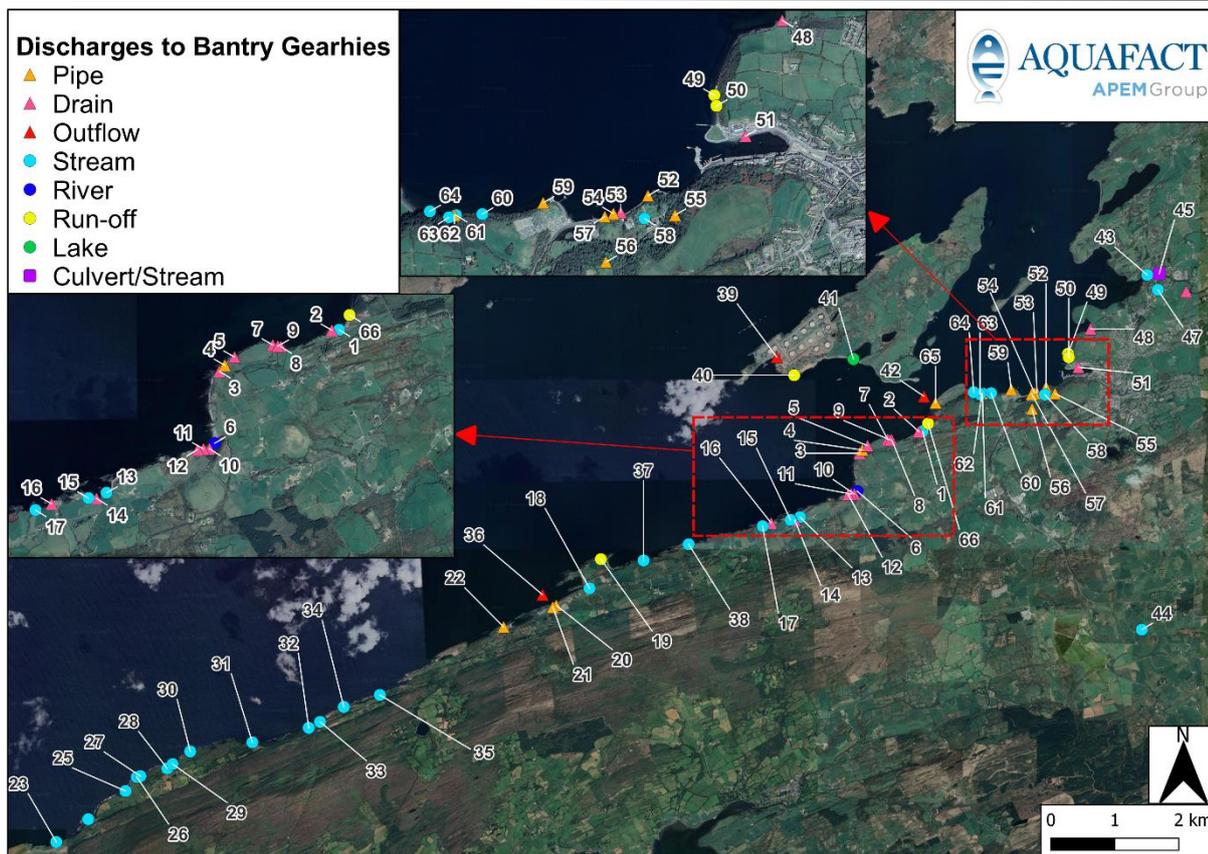
Figure 7-35: Locations of discharges, as observed during the shoreline surveys, into the Bantry Gearhies east and west bivalve mollusc production areas. Note observation 44 can be discounted as an error was made in recording the GPS coordinates for this point.

The shoreline survey revealed a number of potential *E. coli* inputs via three outflows, 15 drains, 12 pipes, five run-off points, 28 streams, one culvert/stream, one river, and one brackish lake (*i.e.*, Kilmore Lake) (**Figure 7-35**). Water quality of river water bodies within the contributing catchment was of High status during the 2016-2021 monitoring period, except for the Bantry_010 River water body which was of Good status according to the EPA¹⁵ (**Figure 8-3**). This coincides with the findings of the shoreline survey where all streams/ivers, where noted, were reported as running clear, with the exception of one stream that had foam present (map ID 1; **Figure 7-35**).

Of the discharges noted during the shoreline survey, 30 out of the 66 were anthropogenic discharges or pipes and as such, the impact due to human activities has the potential to be significant. However, water samples were not taken for all discharge points and due to the potential significance of unidentified discharges, a definitive evaluation cannot be made at this time.

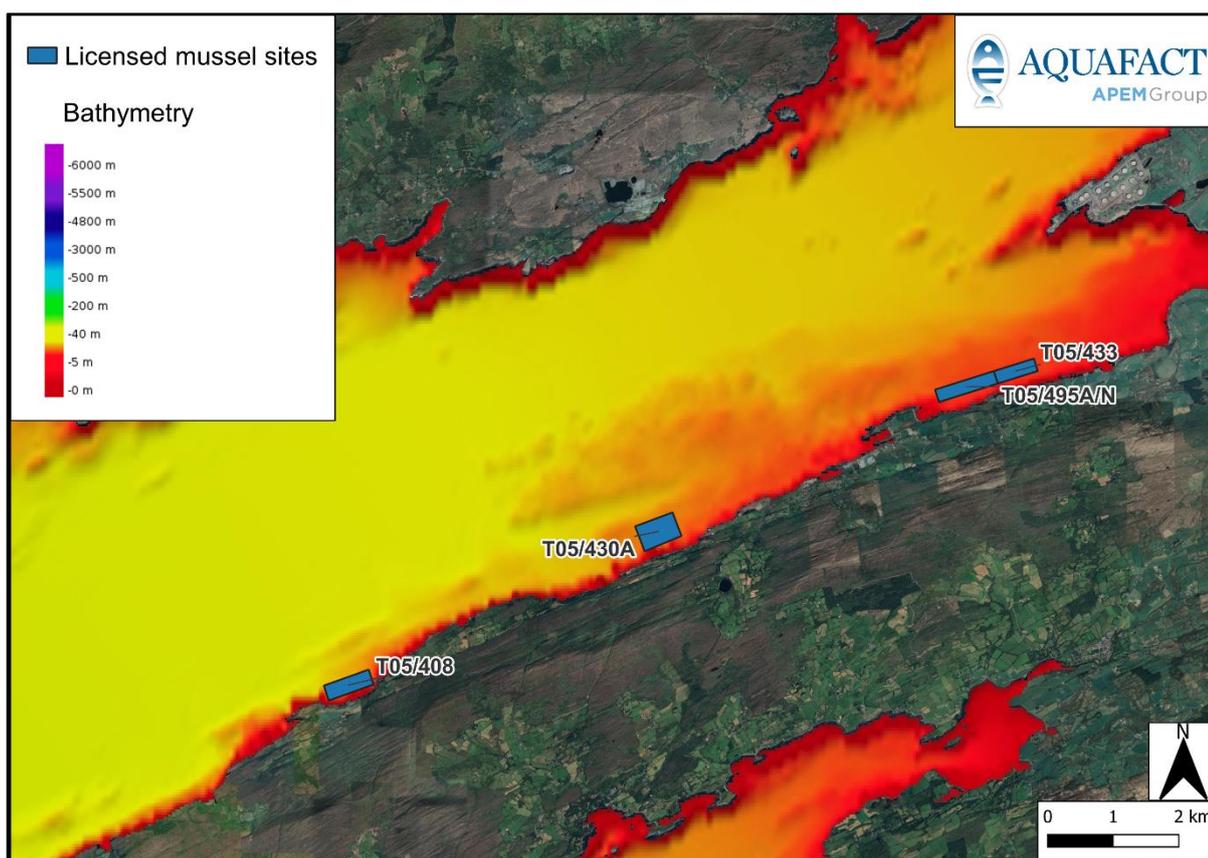
Figure 8-1: Bantry Bay bathymetry (source: EMODnet; licensed under a Creative Commons Attribution 4.0 International (CC BY 4.0) licence).

Bantry Bay is predominantly subtidal and deepens gradually from 30 m near Whiddy Island to greater than 70 m at the mouth of the bay (Raine *et al.*, 1993). **Figure 8-1** illustrates the bathymetry of Bantry Bay.

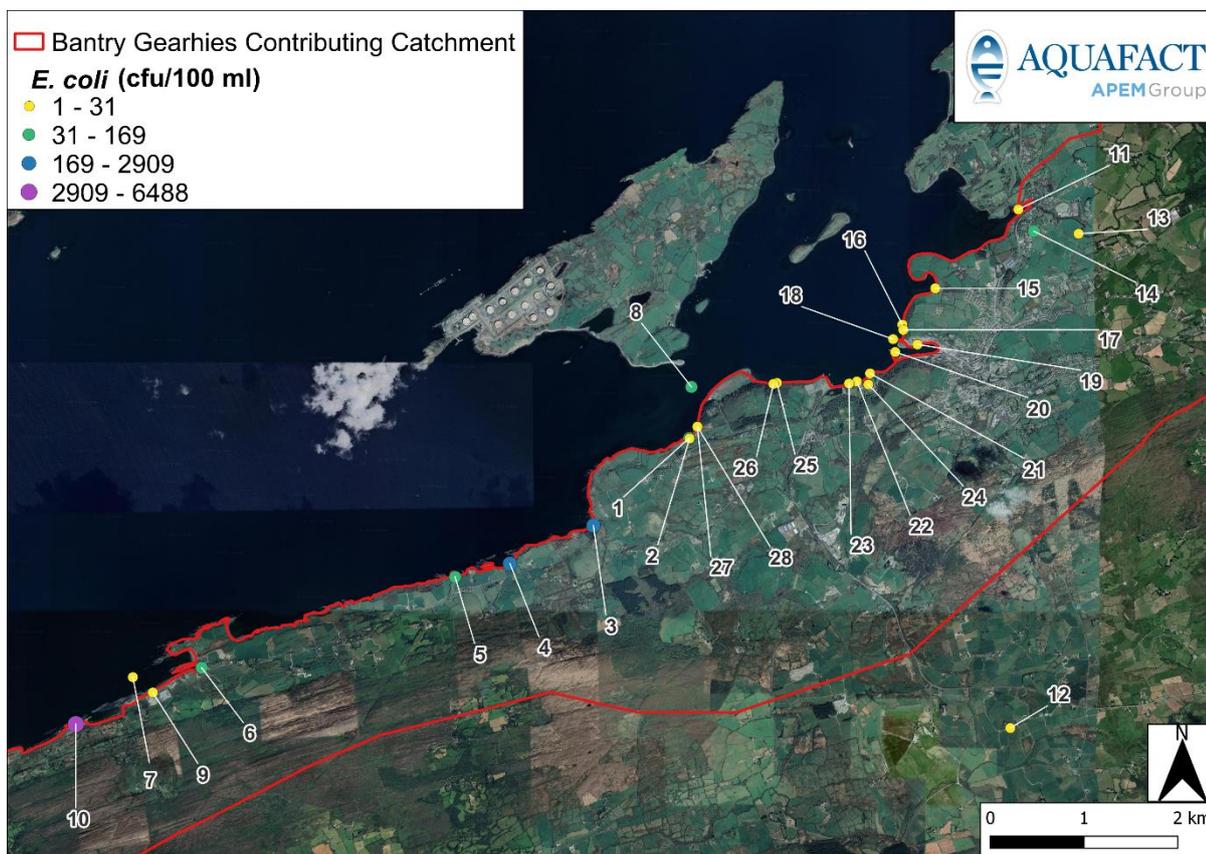
Figure 9-1: Location and magnitude of *E. coli* results from the water samples taken during the shoreline survey (numbering cross-referenced to Table 9.3). Due to an error in recording the GPS coordinates, Station 12 can be discounted.

While the RMPs have been placed based on the ebbing tide, it is of note that on a spring flood tide current speeds are at their highest (0.20 m/s, **section 8.3**), meaning *E. coli* contamination discharging from the Station 9 water sample location is likely to be carried by the current north-eastwards over the mussel sites in Bantry Gearhies east BMPA, reaching site T05/495A-N first and therefore not being immediately detected by RMP 1 east. However, based on the decay rate of *E. coli* (Martin *et al.*, 2023), and hydrodynamic properties in the area, concentrations of this contaminant are likely to have reduced by two orders of magnitude by the time the contamination has reached site T05/495A-N, *i.e.*, reduced from > 6,000 CFU/100 ml to approximately 60 CFU/100 ml. At this much lower concentration, *E. coli* contamination emanating from the Station 9 water sample point is unlikely to have a significant effect on the mussels at this site.
