SANITARY SURVEY AND SAMPLING  
PLAN FOR CLEGGAN BAY, Co.  
GALWAY- APRIL 2025

SEA-FISHERIES  
PROTECTION  
AUTHORITY

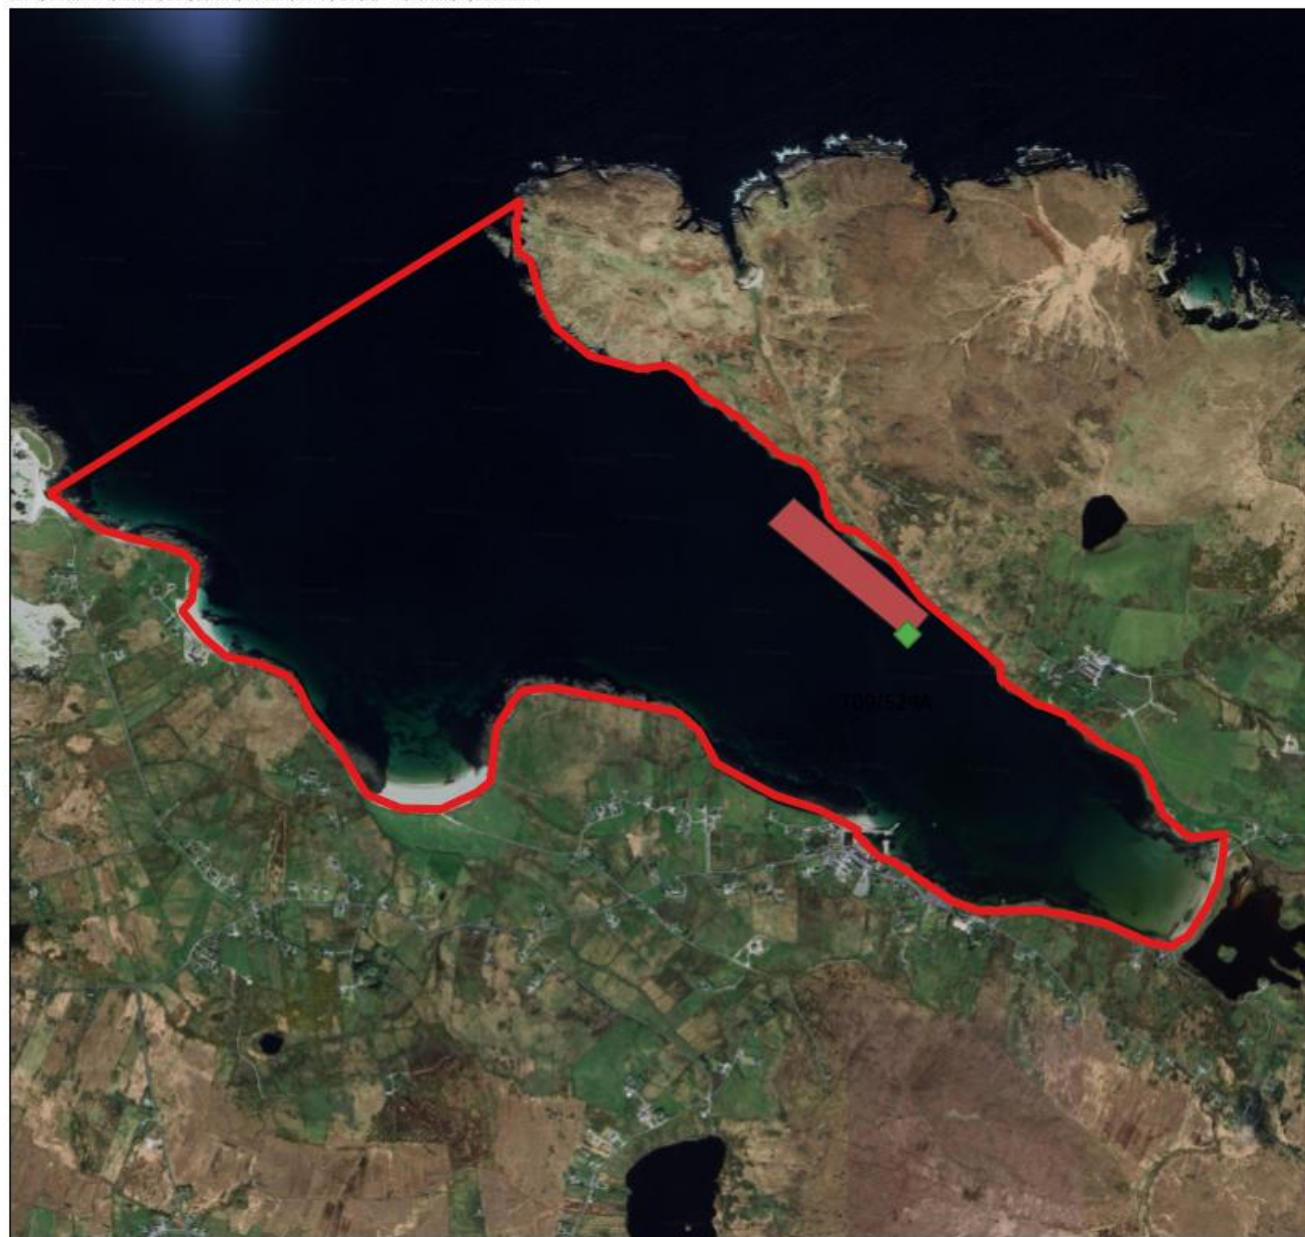
| <p><b>Title</b></p> <p>Location of Representative Monitoring Point<br/>for Blue Mussels</p> | | | |

The recommended RMP is located at ITM coordinates 53.56308 N, -10.10933 W (53° 33' 47.088" N, 10° 6' 33.588" W), within the southern portion of licensed site T09/524A (Figure 6-1).

approximately equidistant from two identified runoff sources and is likely to be influenced by contaminants transported from the Lough Anillaun inflow. Its proximity to agricultural land and associated runoff further supports its suitability as a monitoring site, ensuring the RMP captures potential faecal contamination from rural sources.

In contrast, pollution originating from Cleggan Village, despite the high recorded levels of *E. coli*, is unlikely to circulate to the licensed area due to prevailing hydrodynamic conditions. As a result, considering the size of the BMPA, prevailing circulation patterns, and the current status of the licensed site, a single RMP is recommended.
